Relazione Finale sulla Verifica di Ottemperanza in Corso d'Opera alla
Prescrizione A.42

**OPL00-C493-601-Y-TPF-0002- Monitoraggio dei Mammiferi Marini. Nota Tecnica:
Guasto del Sistema di monitoraggio "Sonoboa" e soluzioni alternative indivi-
duate**

Monitoraggio dei Mammiferi Marini

Nota Tecnica: Guasto del Sistema di monitoraggio "Sonoboa" e soluzioni alternative individuate

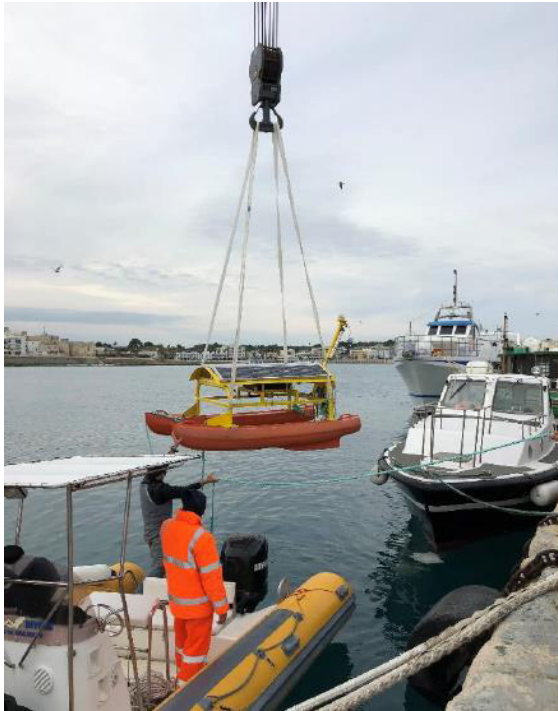
7. Recupero in porto

Figura 3.1: Recupero della Sonoboa – 1 Dicembre 2018

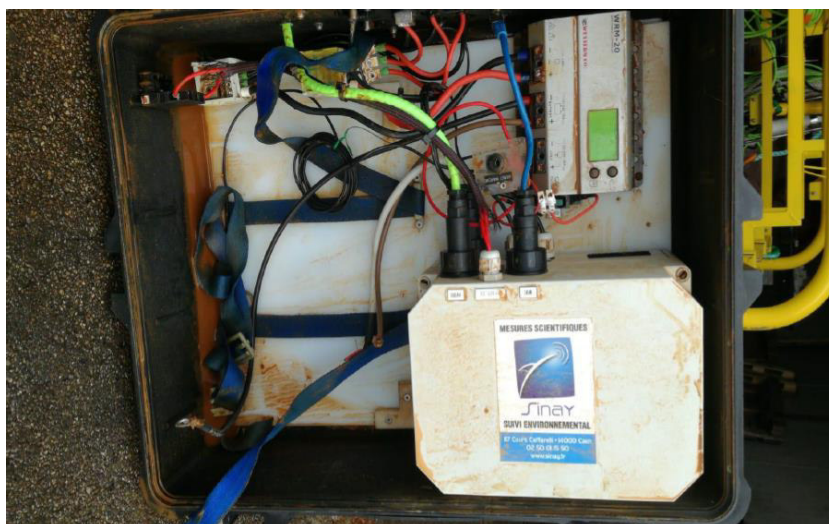
1. Sistema di registrazione

- rottura dell'antenna utilizzata per il trasferimento dei dati misurati dall'idrofono;
- danneggiamento di tutti i sistemi elettronici contenuti nel casing a seguito dell'ingresso di acqua di mare (tenuta non progettata per sopportare una immersione per più giorni);
- rottura di No.1 pannello solare;
- rottura della batteria a seguito del contatto prolungato con acqua di mare.
