**Area Pozzo Agosta 001 Dir – Analisi degli scenari  
incidentali previsionali in fase di coltivazione degli  
impianti in area pozzo e della condotta da 4**

16-19-22834-ASI-AGO1

**Area Pozzo Agosta 001 Dir**  
**Analisi degli scenari incidentali previsionali in fase di**  
**coltivazione degli impianti in area pozzo e della condotta da 4"**  
**di consegna alla SNAM**

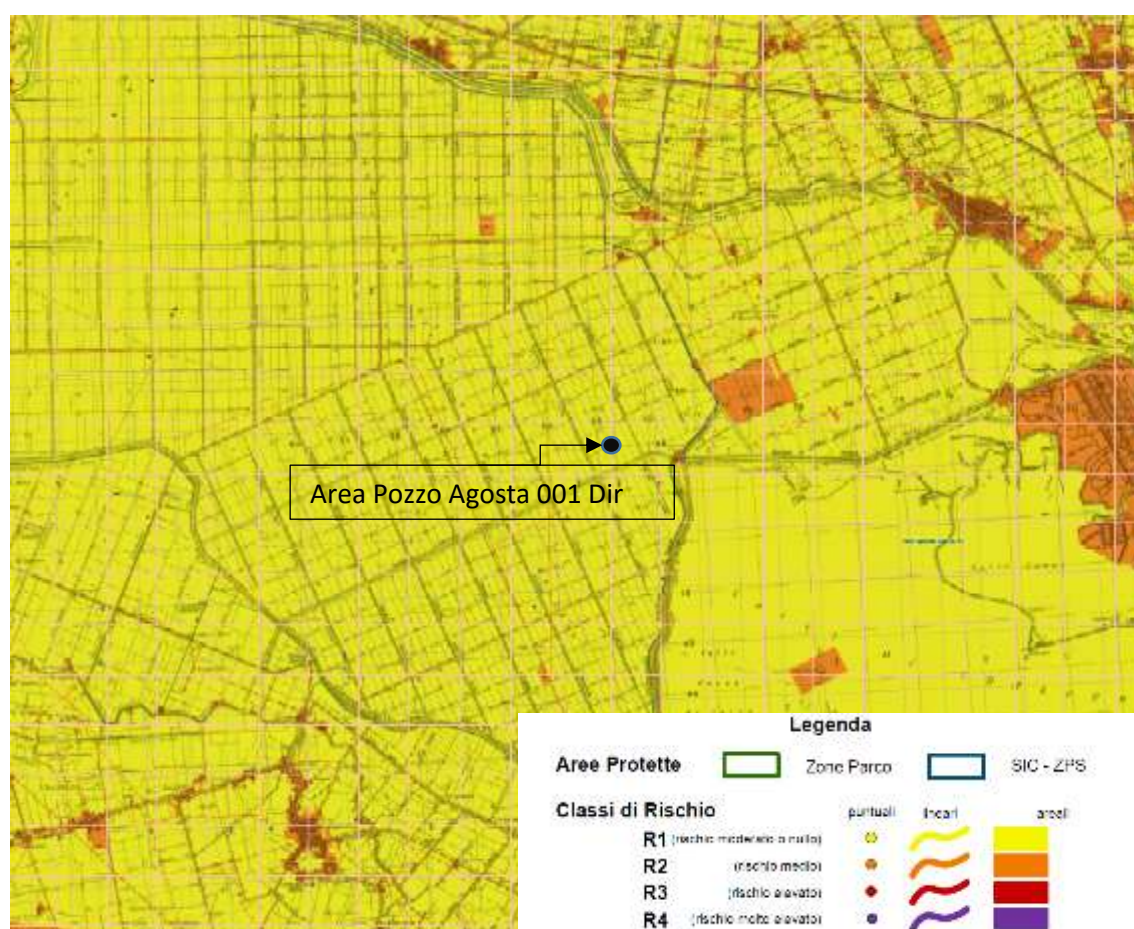
Figura 10 – Stralcio della Tavola "205SO-Menate" del Piano di Gestione del rischio di Alluvione

Il territorio in cui risulta ubicato l'area in esame (punto nero sulla mappa), all'interno del comune di Comacchio (FE) risulta contenuto nel distretto idrografico UoMITN008 - Autorità di Bacino del fiume Po.

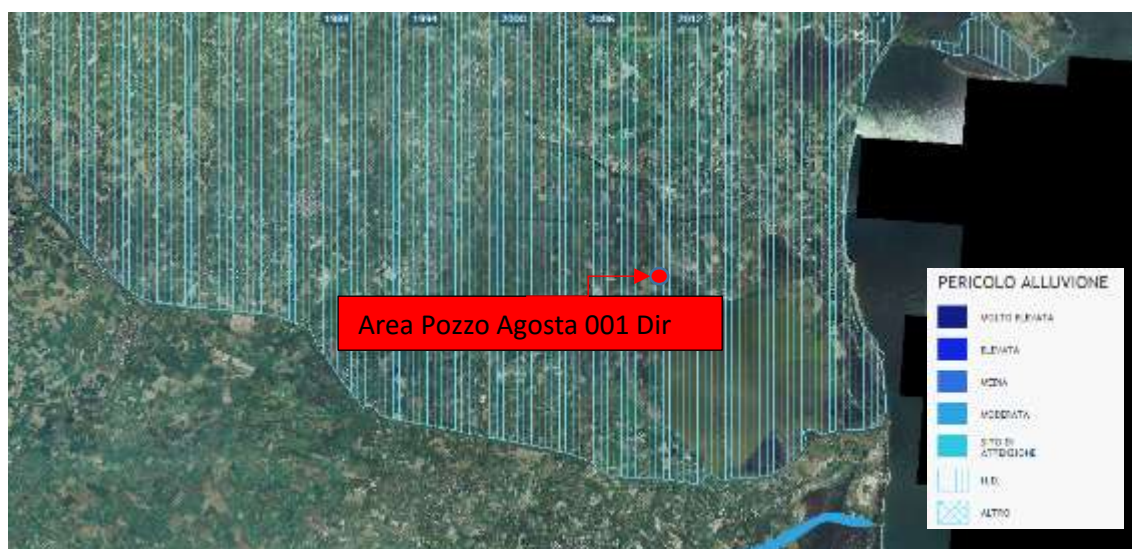
*Figura 11 - Rischio idraulico fenomeni esondazione - PAI*

L'area di ubicazione dell'impianto si trova in una zona non interessata da rischio idraulico per fenomeni di esondazione e si ritiene quindi non soggetta a fenomeni di allagamento; pertanto non si ritiene necessario proseguire la trattazione secondo le modalità indicate in premessa.
