# PONTE SULLO STRETTO DI MESSINA

## PROGETTO DEFINITIVO

The report contains the results of the special design investigations of hanger replacement and hanger rupture considered at the ultimate limit state. All results presented in the report are based on the global IBDAS beam-model version 3.3.

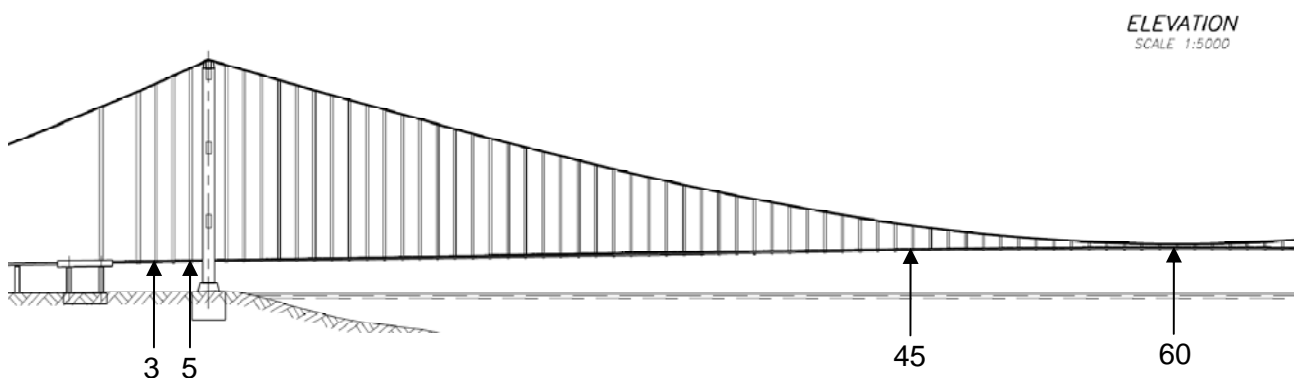
For the verification of the suspended deck structure during the hanger replacement a few different locations has been selected in the side span and in the main span, see Figure 2-1. The result of the analysis for the suspended deck can be seen in the following ADVERS output figures. Only the roadway girder has been considered.

Figure 2-1 Location of selected hangers considered for replacement

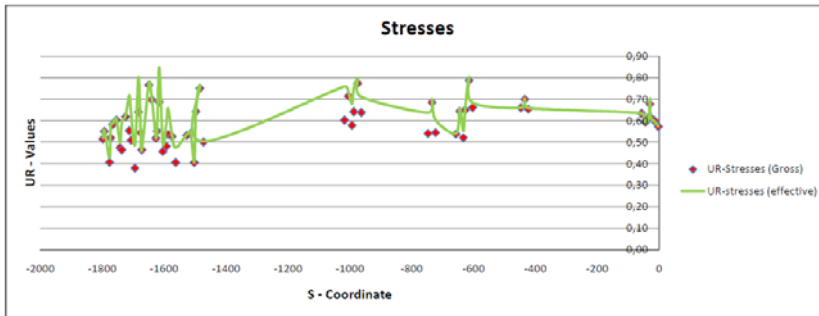
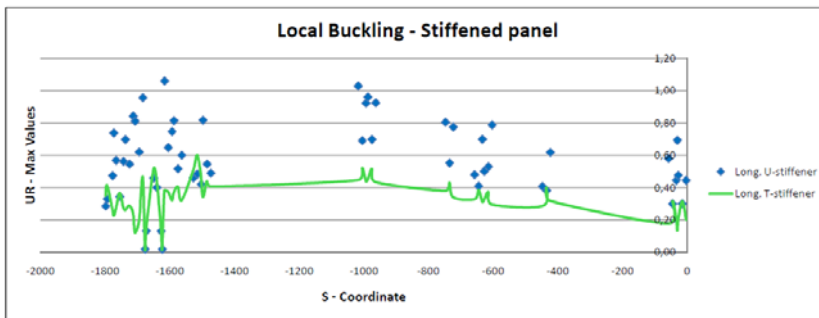
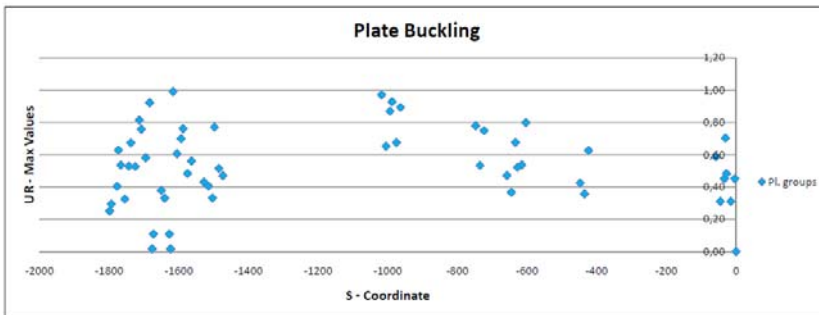
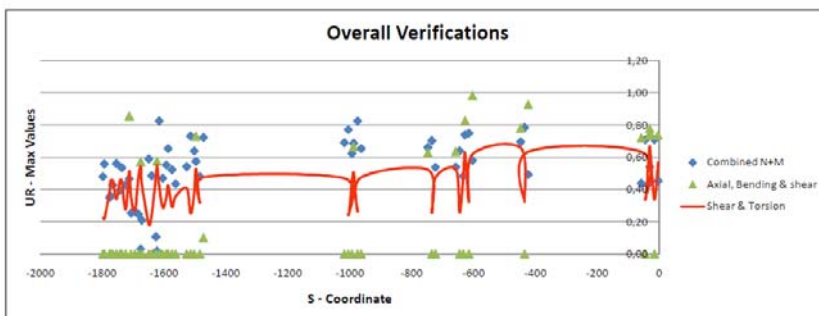
Figure 2-2 Roadway girder, ADVERS results for replacement of hanger 3 (s=-1740 m)

From the results for hanger 3 it can be seen that a buckling problem occurs for the longitudinal trough stiffeners (U-stiffeners). This problem is mainly for the stiffeners located on the bottom plate, since a larger span result in increased compressive stresses at this location.

From ADVERS the following results are obtained for the roadway girder for the hanger replacement operation of hangers 3, 5, 45 and 60.

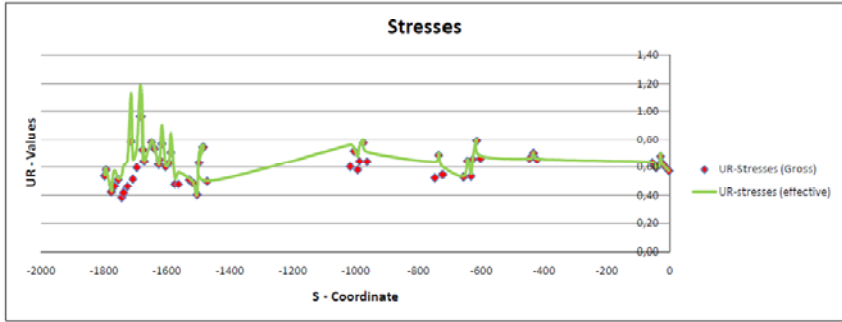
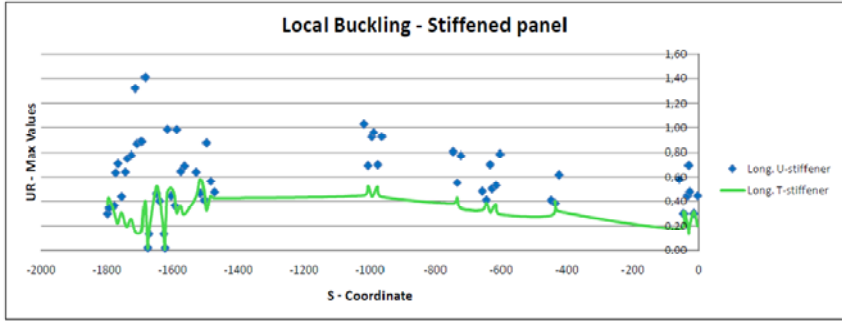
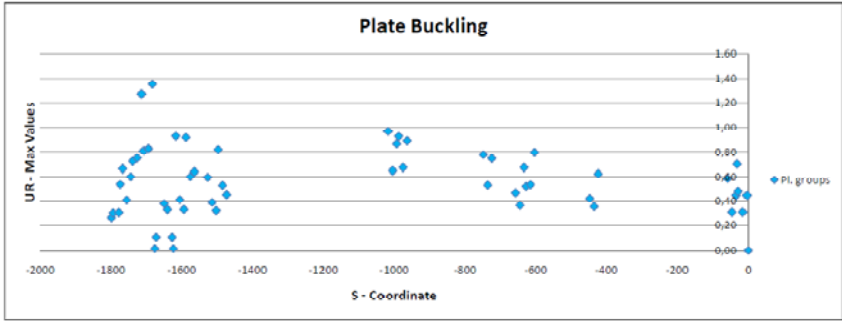
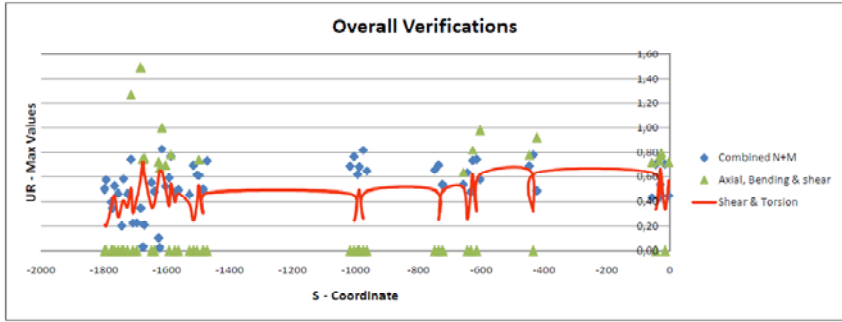
Figure 2-3 Roadway girder, ADVERS results for replacement of hanger 5 (s=-1680 m)

From the results for hanger 5 it can be seen that a severe stress problem occurs in the side span at the location of the missing hanger with a utilisation ratio of  $UR=1.20$ . This will demand a significant reinforcement of the girder steel in order to cope with this demand. Also large buckling problem occurs for the longitudinal trough stiffeners. This problem is due to the increase in span length at the drop-in span from 60 m to 90 m. It is mainly for the stiffeners located on the bottom plate due the larger span length increases compressive stresses at this location.

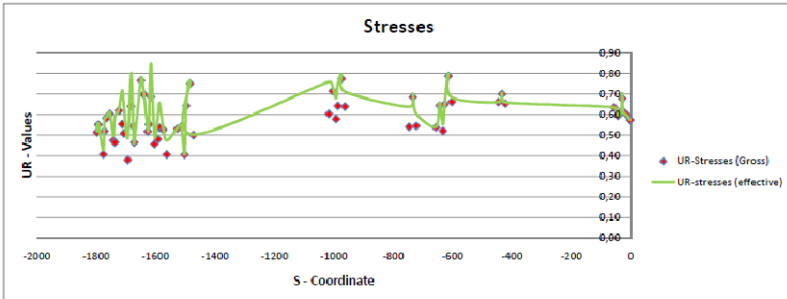
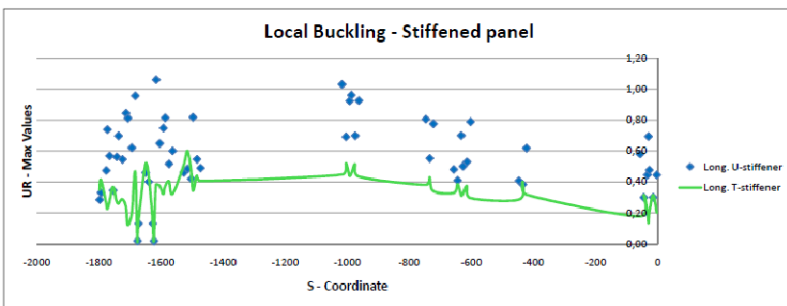
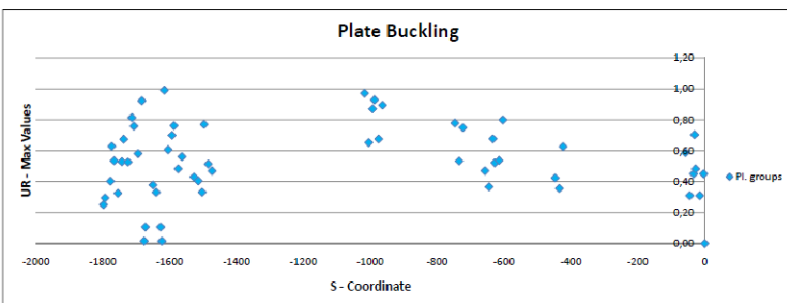
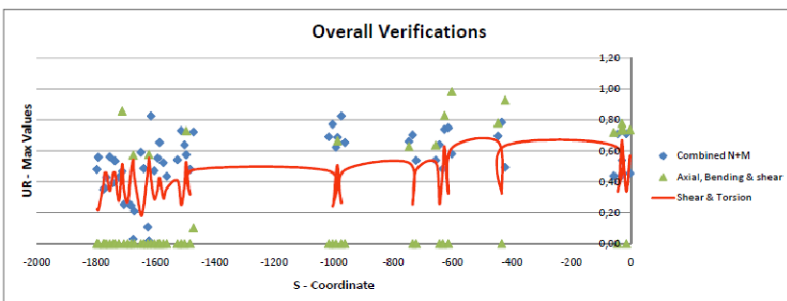
Figure 2-4 Roadway girder, ADVERS results for replacement of hanger 45 (s=-450 m)

From the results for hanger 45 it can be seen that all utilisation ratios are below 1.00 at the hanger location, and a replacement here is therefore possible considering the suspended deck structure.

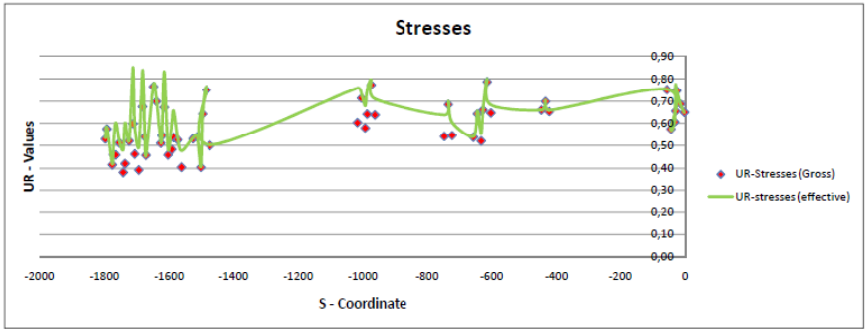
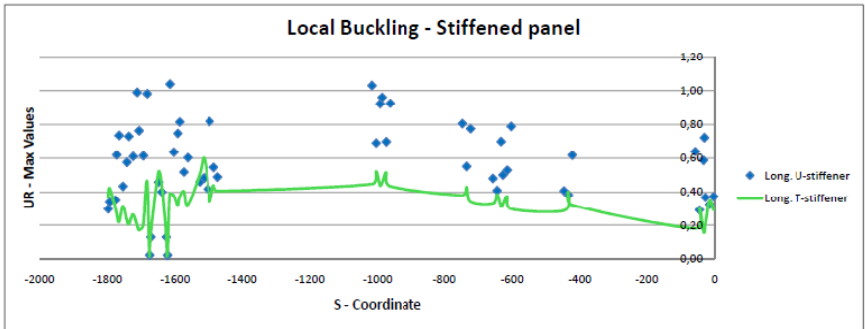
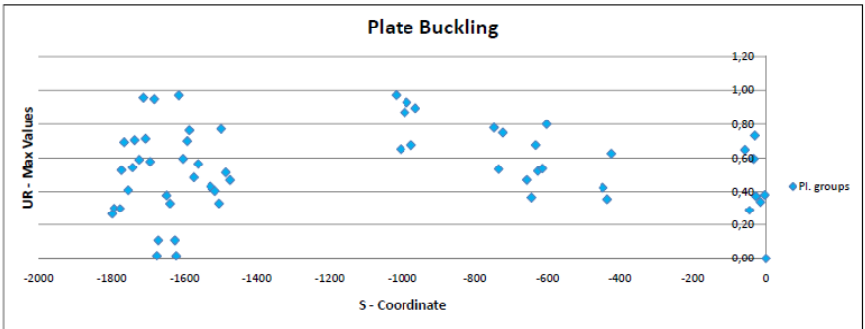
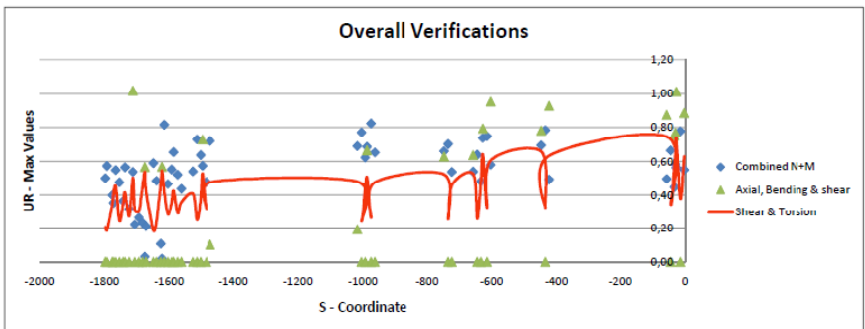
Figure 2-5 ADVERS results for replacement of hanger 60 (s=0 m)

From the results for hanger 60 it can be seen that a larger shear force is introduced at the adjacent spans resulting in a utilisation factor of  $UR=1.02$  demanding reinforcement of the girder at this location due to the replacement operation.

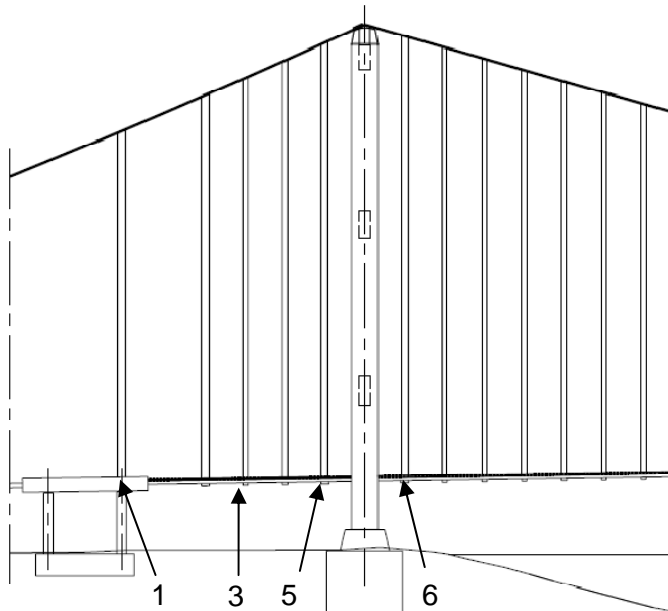
For the verification of the suspended deck structure during the hanger rupture a few different locations has been selected in the side span and at the towers, see Figure 3-1. These locations have been chosen due to expectation of large dynamic effects in this area. Most critical is the tie-down hanger and the hangers supporting the 60m drop-in span, since the girder span will increase significantly during rupture.

Figure 3-1 Location of hangers considered for rupture

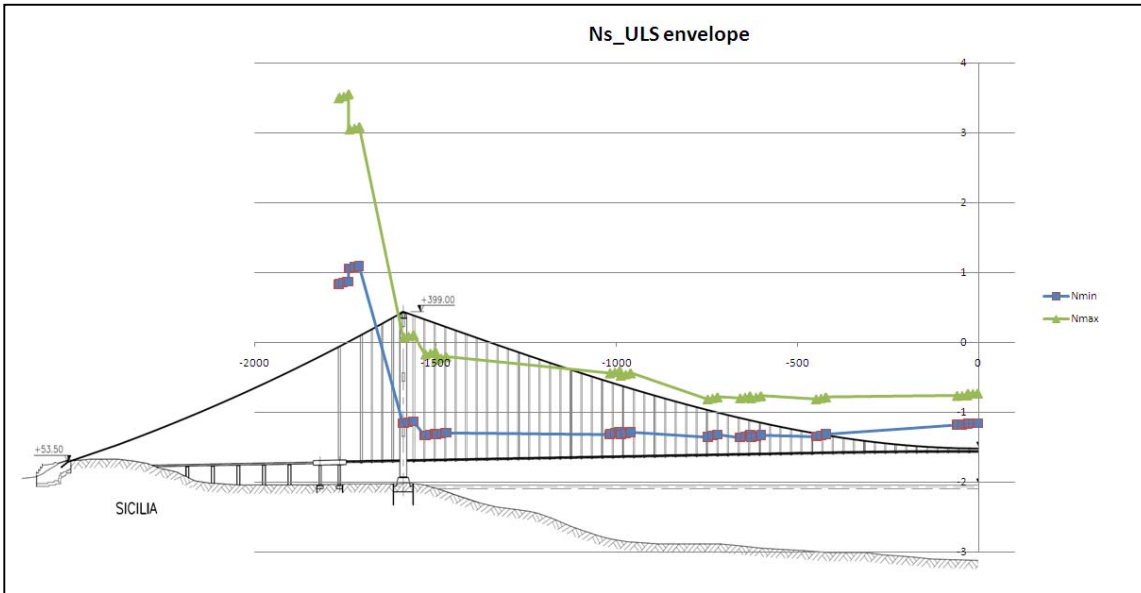
Figure 3-2 Sectional forces in road girder for rupture of hanger 1, Normal force (MN)

Sectional force curves are given in the following illustrating the calculated sectional forces from the global IBDAS model in few discrete points. These curves illustrate the behaviour and effect in the girder due to rupture of selected hangers. All results are ULS envelopes and show the max sectional forces in 3-4 points within a girder section.

From the various section force curves it is evident that rupture of a hanger has a large effect on the adjacent spans, indicated by a peak in forces at the location of rupture mainly due to the dynamic effects. It can also be seen that the effect fades out rapidly through the bridge. Largest effects are visible in the side span due to the rigidity of the shorter span here enlarges the dynamic effect from the cables.

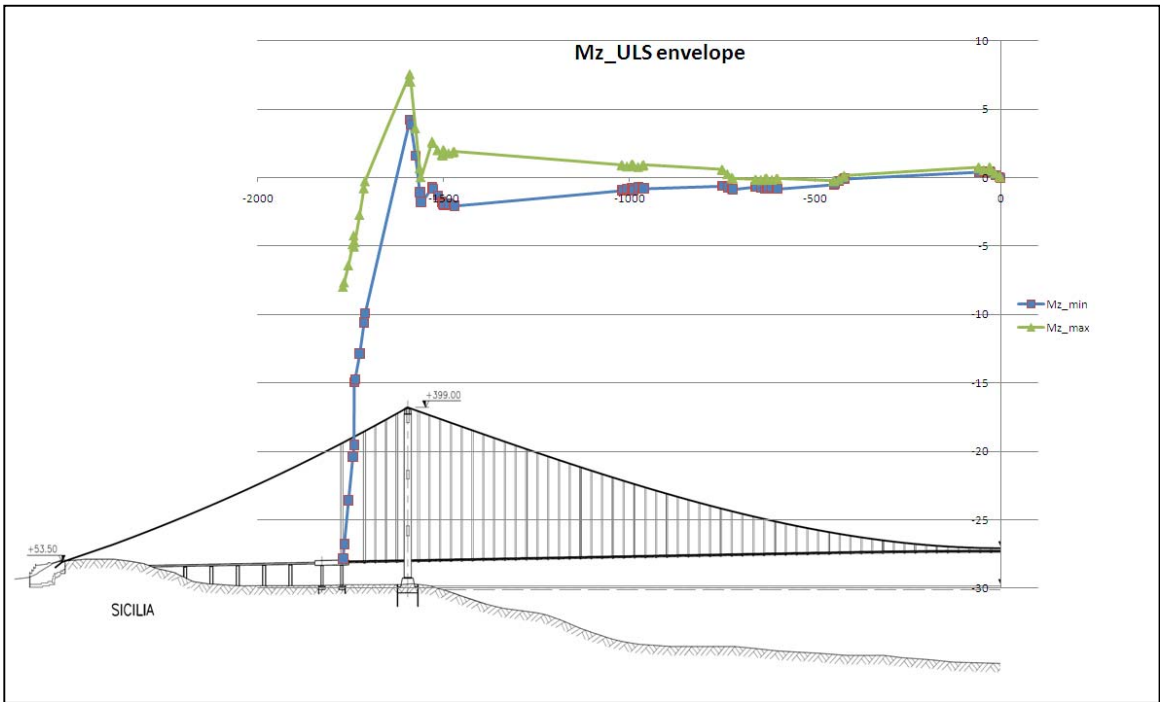
Figure 3-4 Sectional forces in road girder for rupture of hanger 1, Moment (MNm)

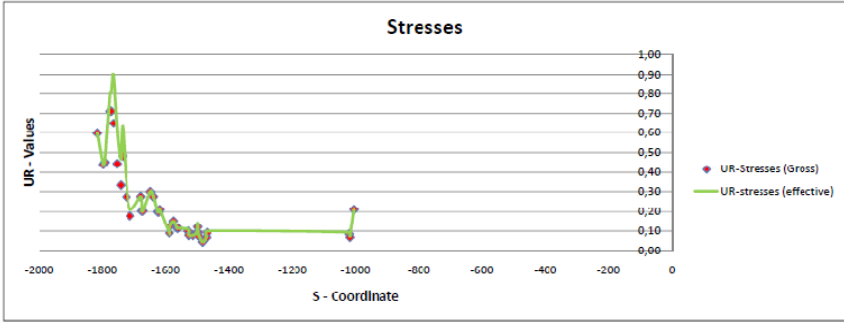
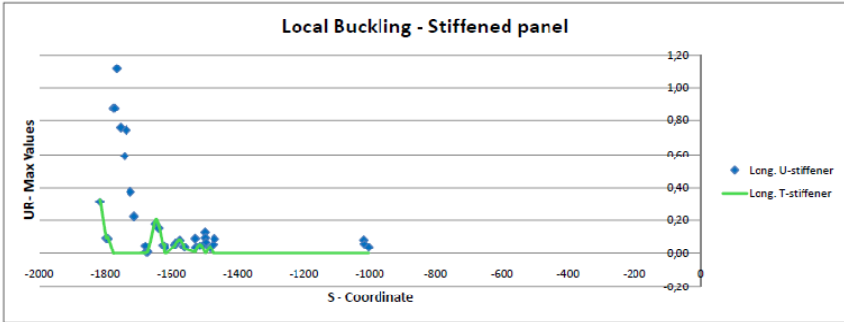
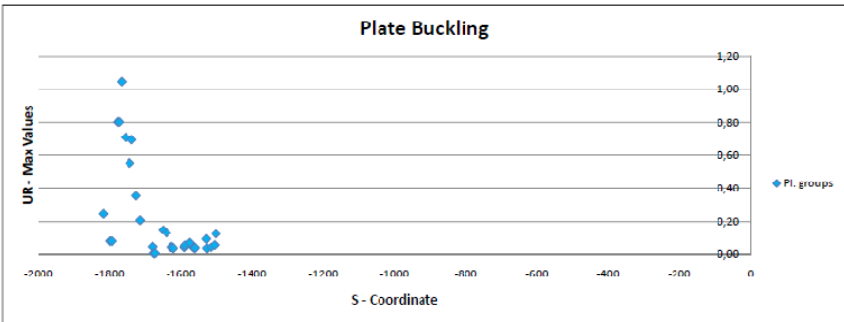
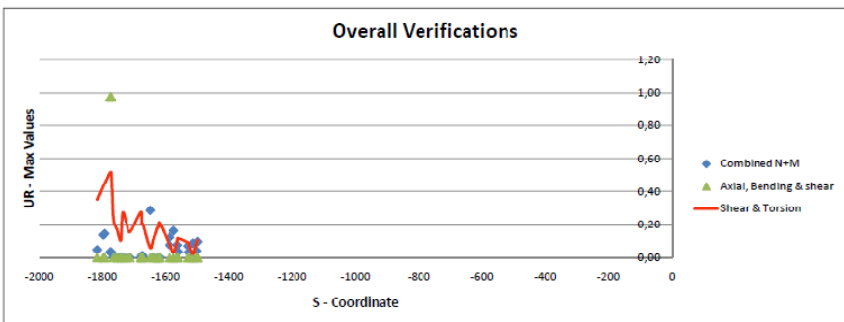
Figure 3-5 ADVERS results for rupture of Hanger 1, roadway girder

The calculations of the effect of hanger rupture on the roadway girder can be seen in the following figures. It can be seen that the roadway girder has sufficient capacity in case of rupture of the considered hangers. For rupture of hanger 1 and 5 a utilisation factor  $UR > 1.00$  are calculated for local buckling of stiffeners. However, this calculation is for a location close to a cross girder, where buckling is not to be considered, and in the adjacent point no buckling problems occur, thus indicating that no problem exists.

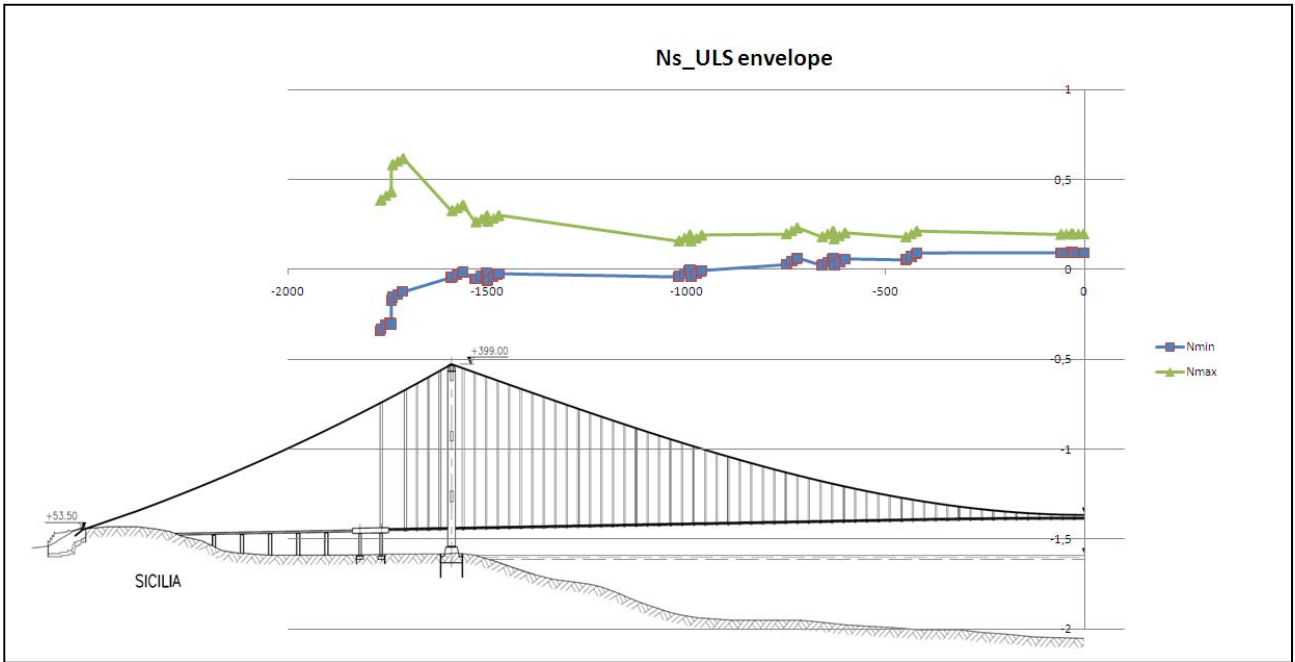
Figure 3-6 Sectional forces in road girder for rupture of hanger 3, Normal force (MN)

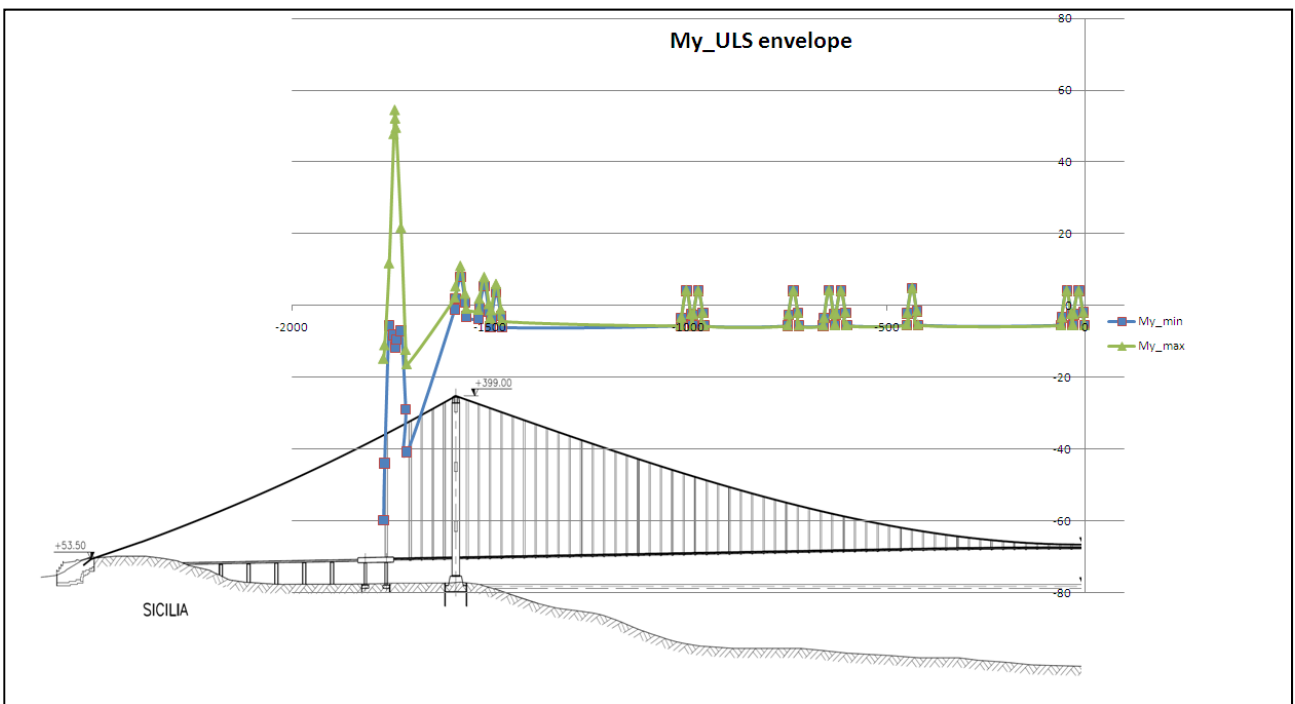
Figure 3-7 Sectional forces in road girder for rupture of hanger 3, Moment (MNm)

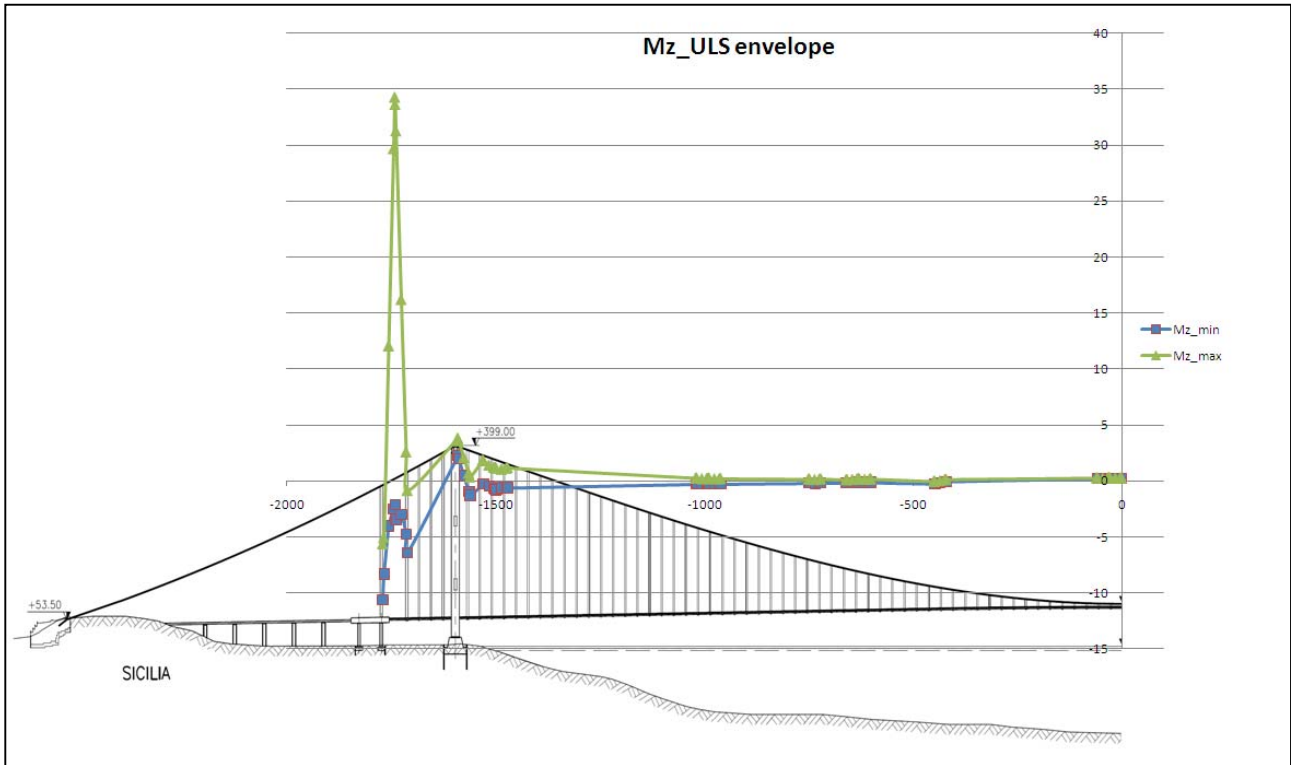
Figure 3-8 Sectional forces in road girder for rupture of hanger 3, Moment (MNm)

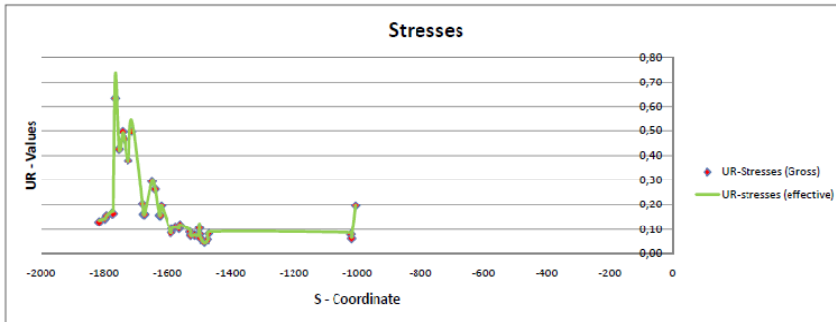
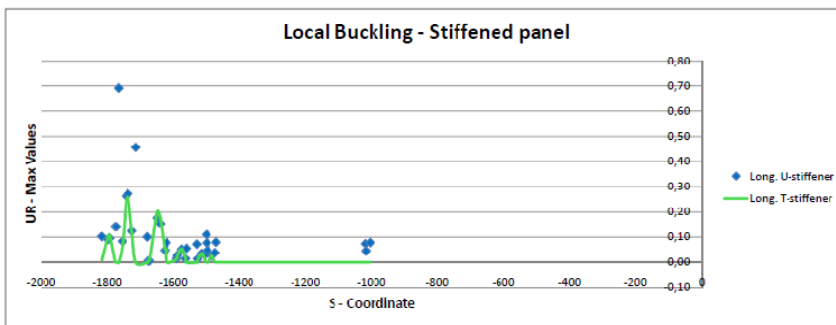
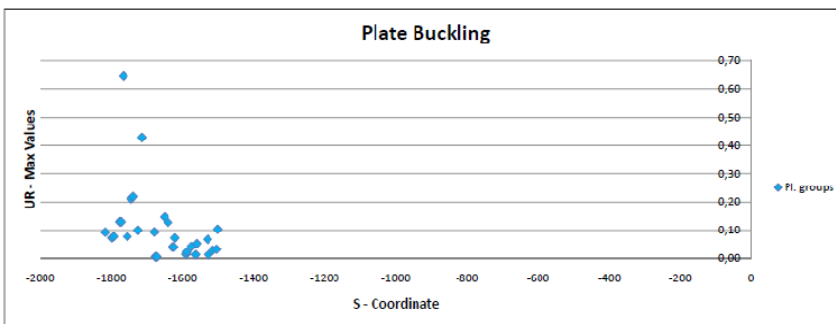
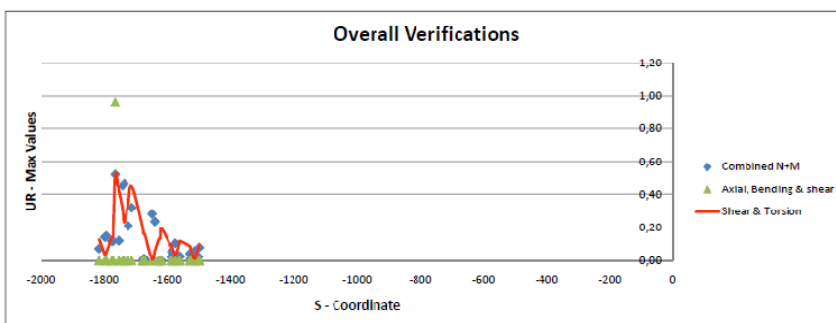
Figure 3-9 ADVERS results for rupture of Hanger 3, roadway girder

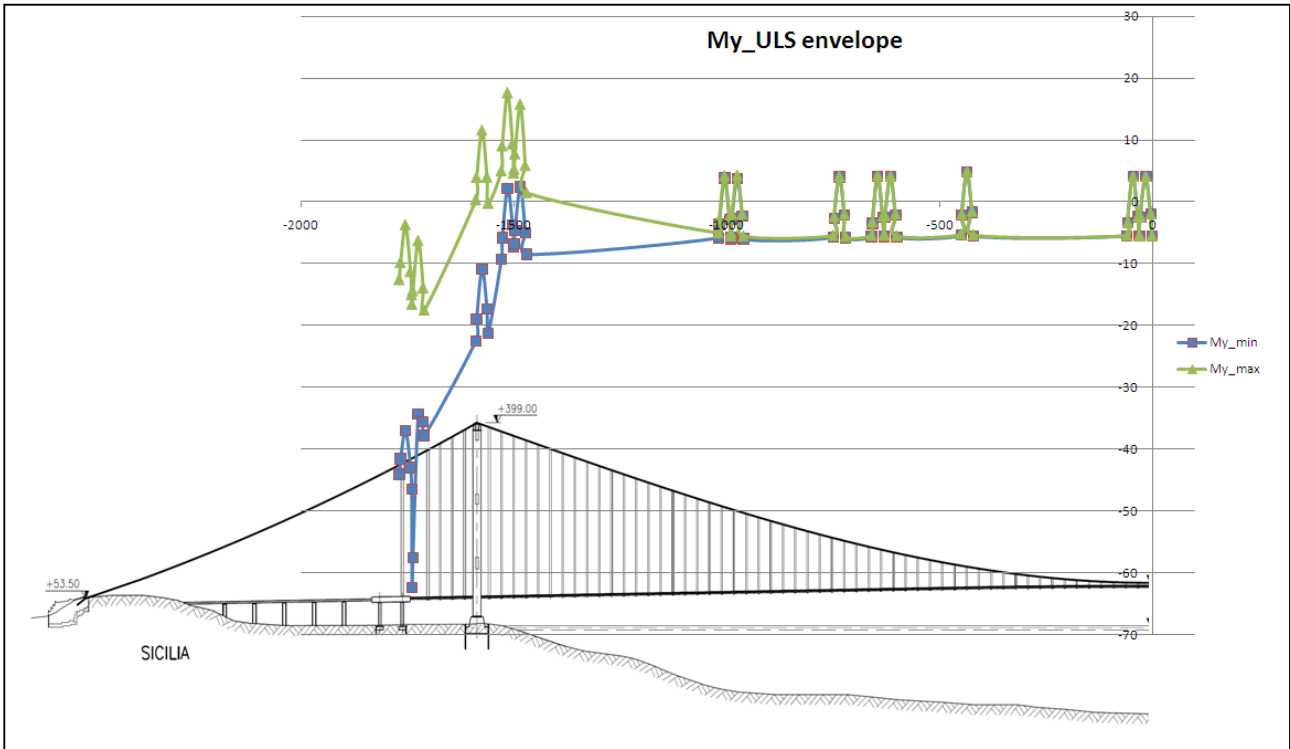
Figure 3-11 Sectional forces in road girder for rupture of hanger 5, Moment (MNm)

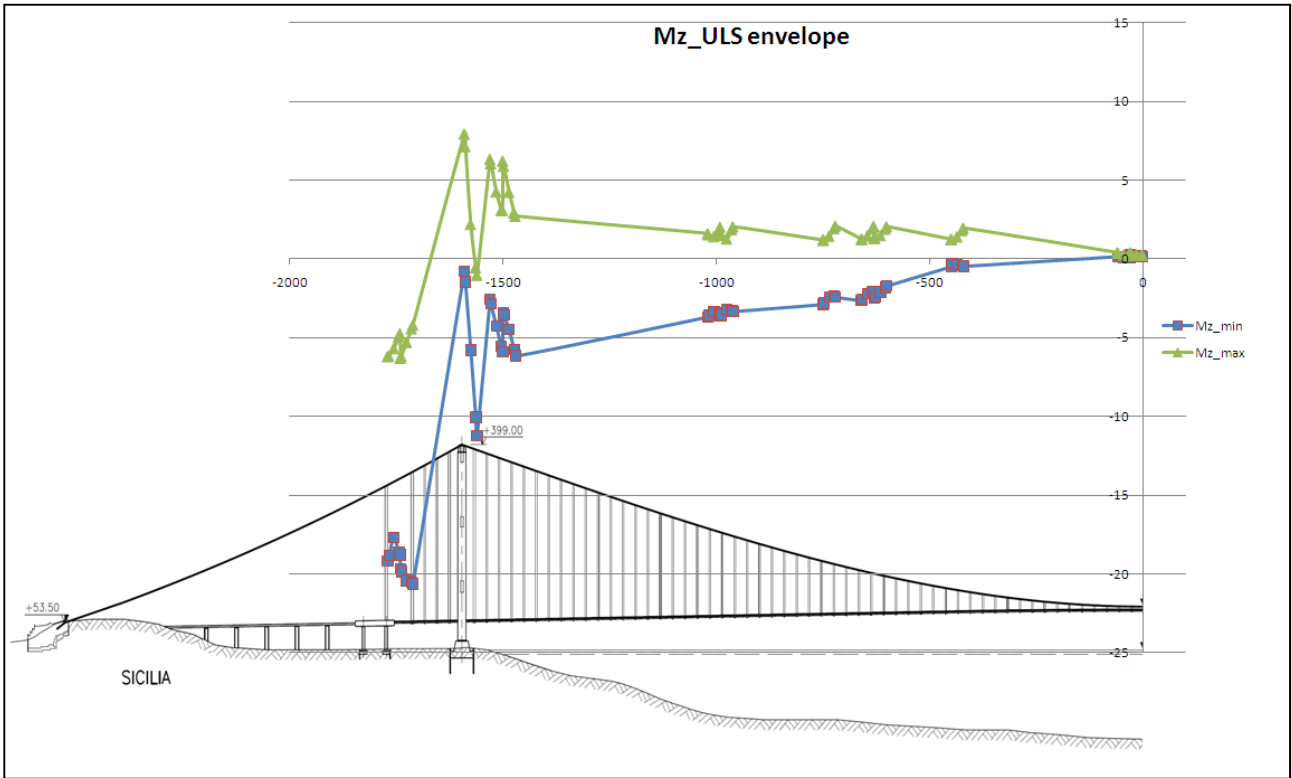
Figure 3-12 Sectional forces in road girder for rupture of hanger 5, Moment (MNm)

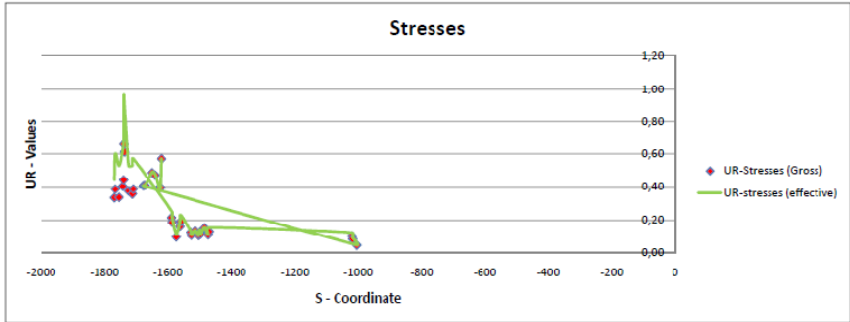
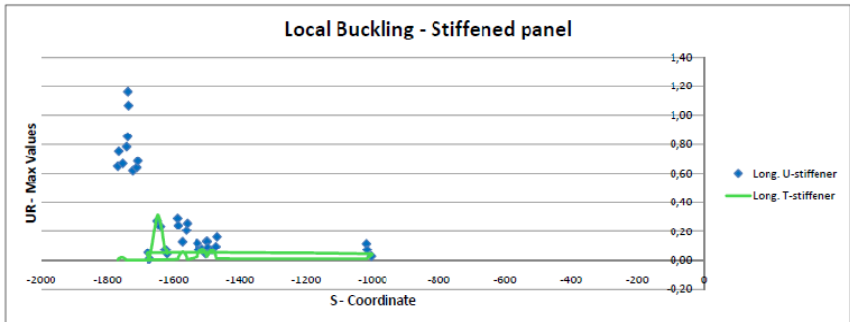
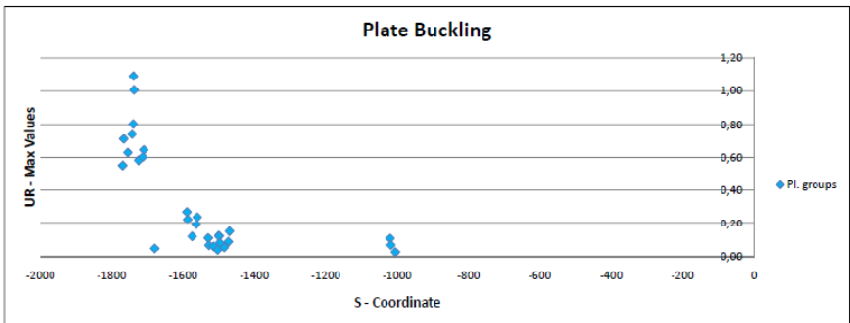
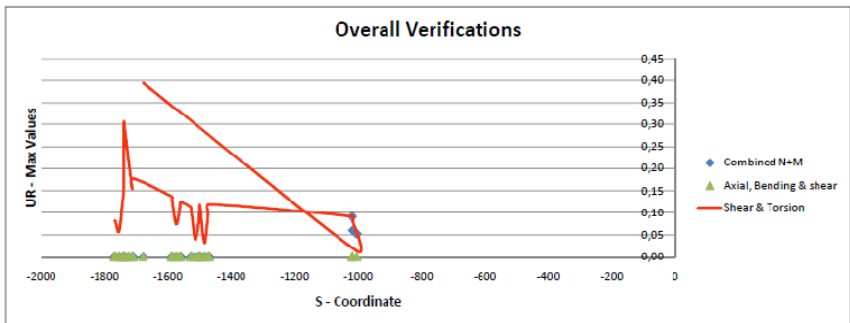
Figure 3-13 ADVERS results for rupture of Hanger 5, roadway girder

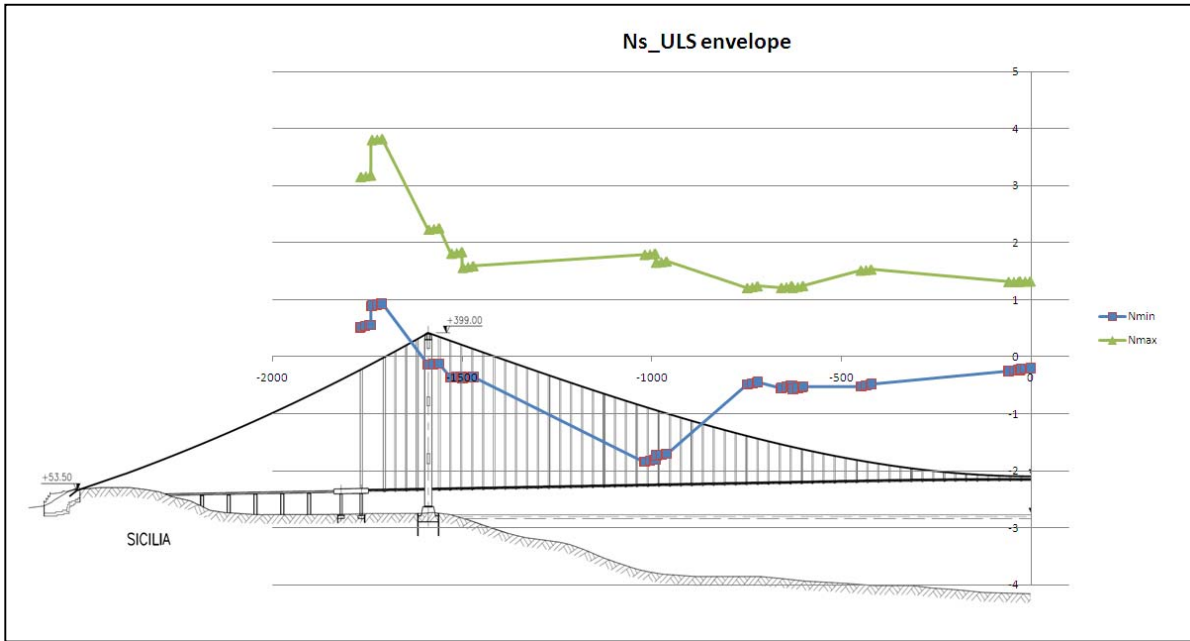
Figure 3-14 Sectional forces in road girder for rupture of hanger 6, Normal force (MN)

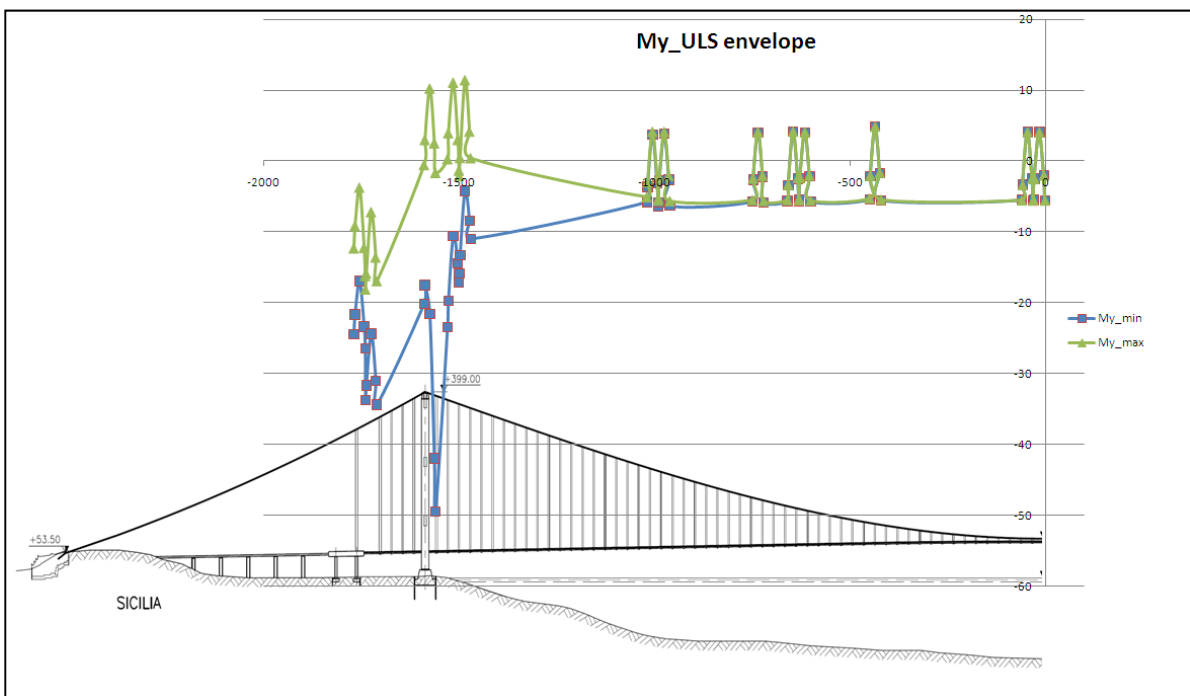
Figure 3-15 Sectional forces in road girder for rupture of hanger 6, Moment (MNm)

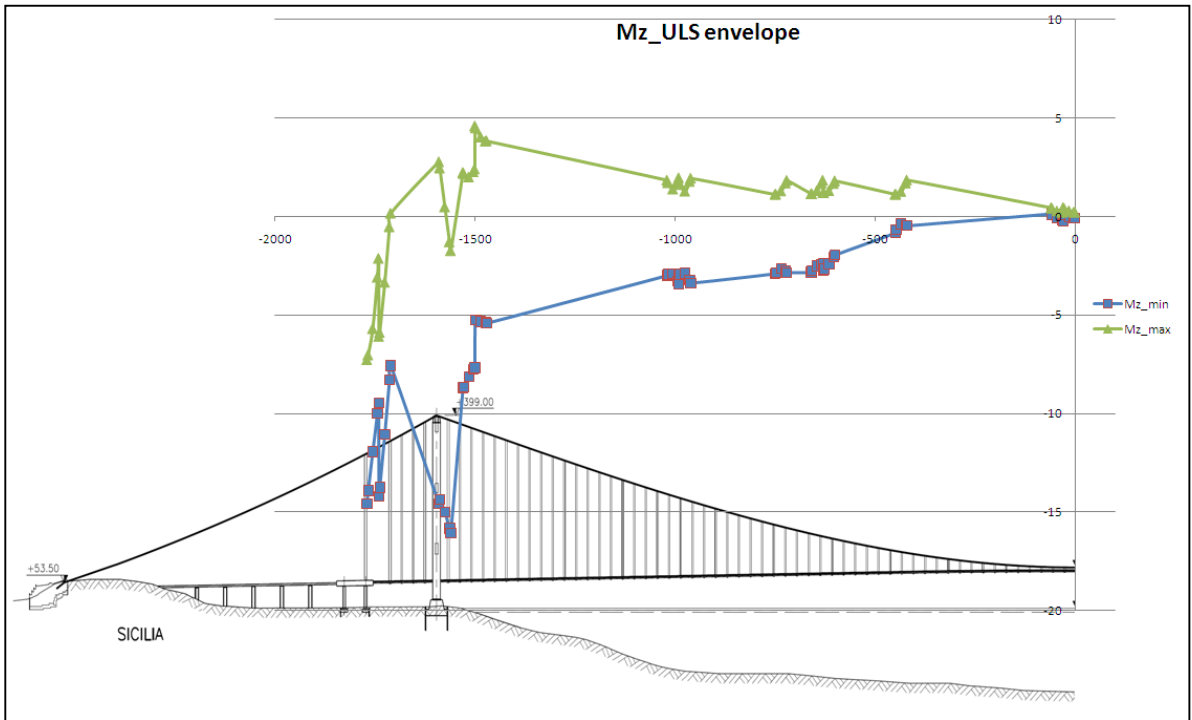
Figure 3-16 Sectional forces in road girder for rupture of hanger 6, Moment (MNm)

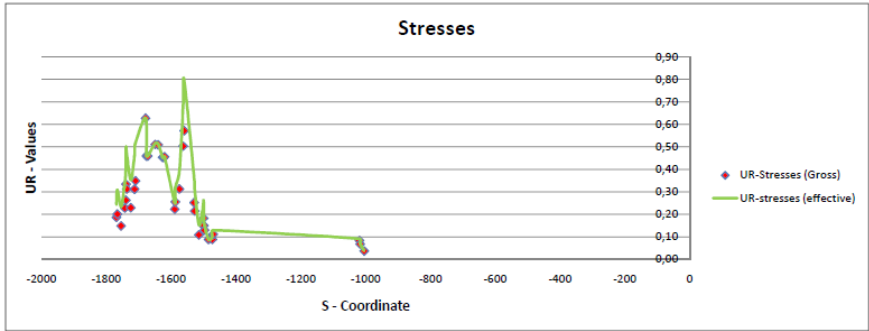
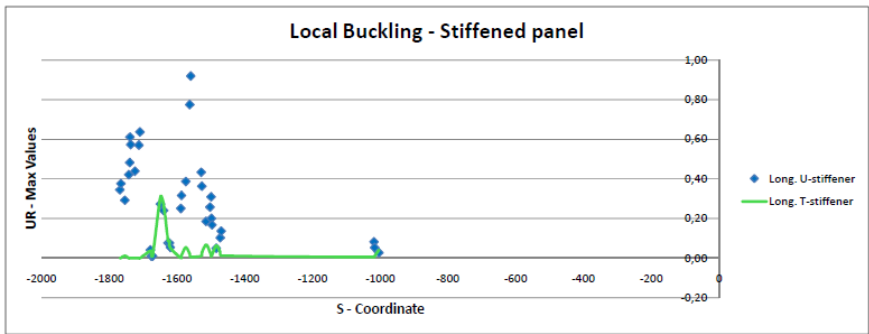
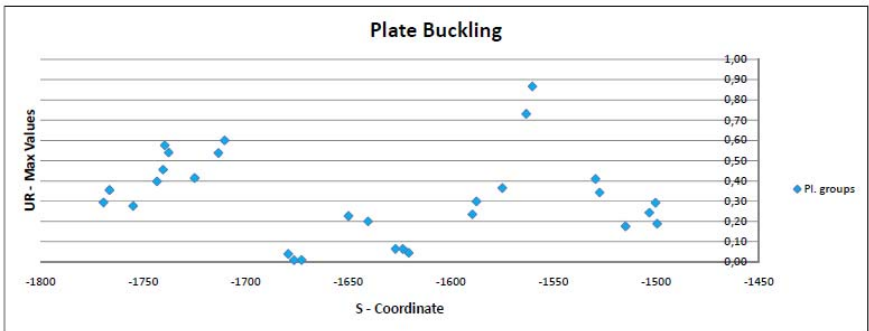
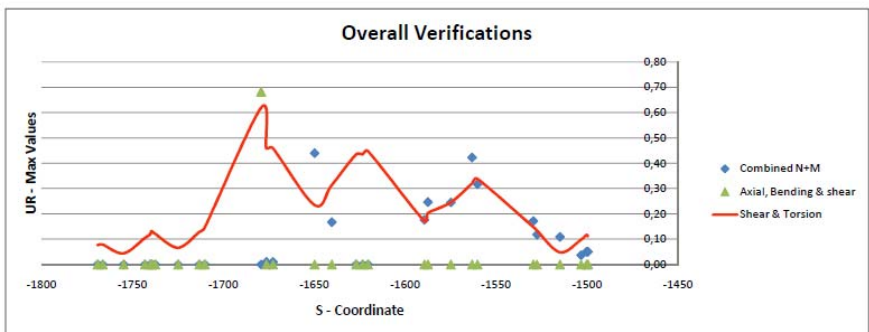
Figure 3-17 ADVERS results for rupture of Hanger 6, roadway girder

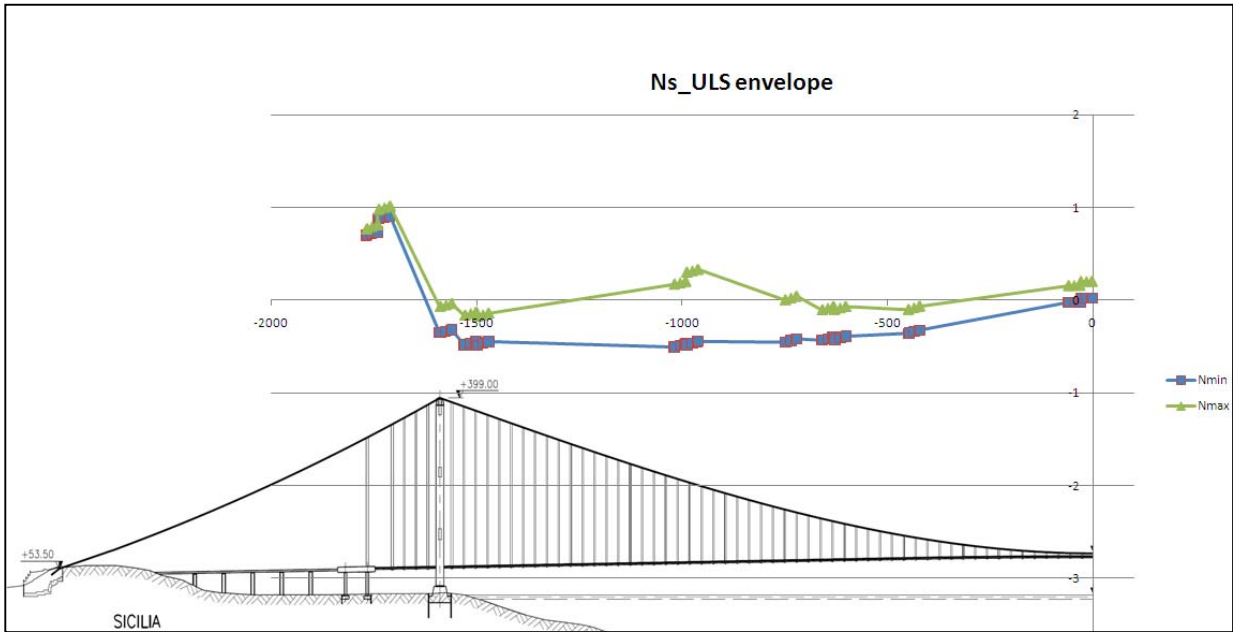
Figure 3-18 Sectional forces in road girder for rupture of hanger 30, Normal force (MN)

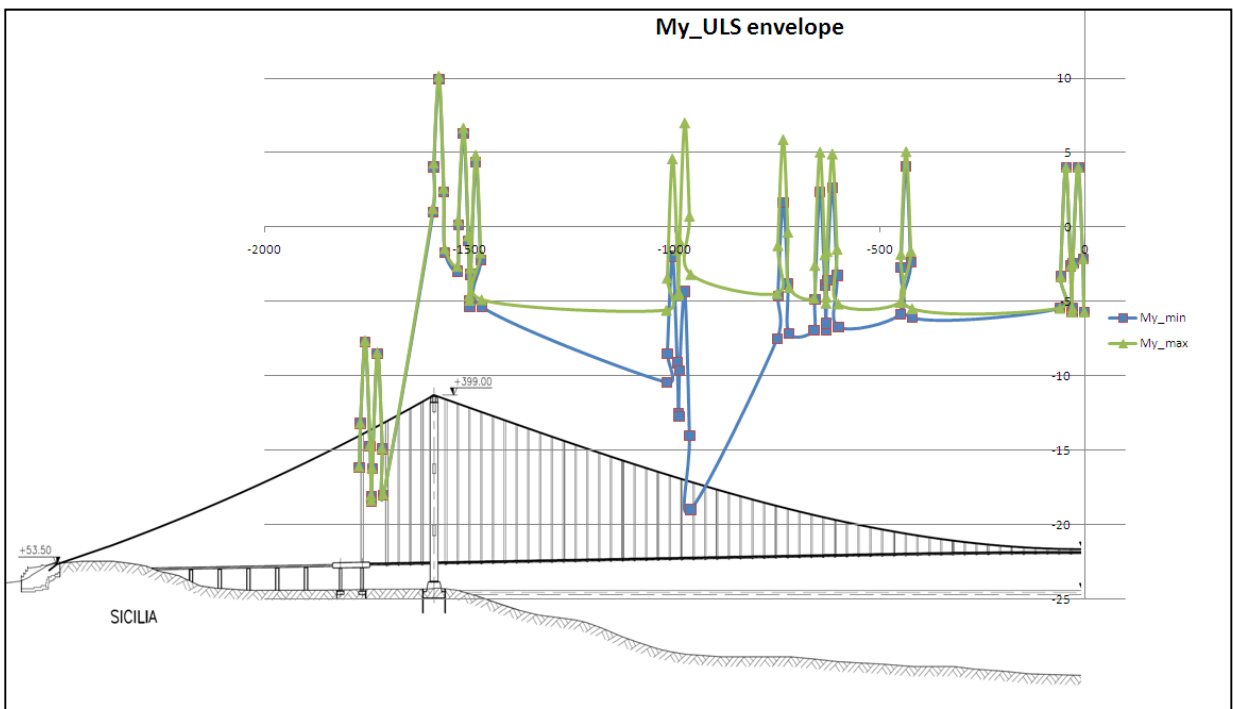
Figure 3-19 Sectional forces in road girder for rupture of hanger 30, Moment (MNm)

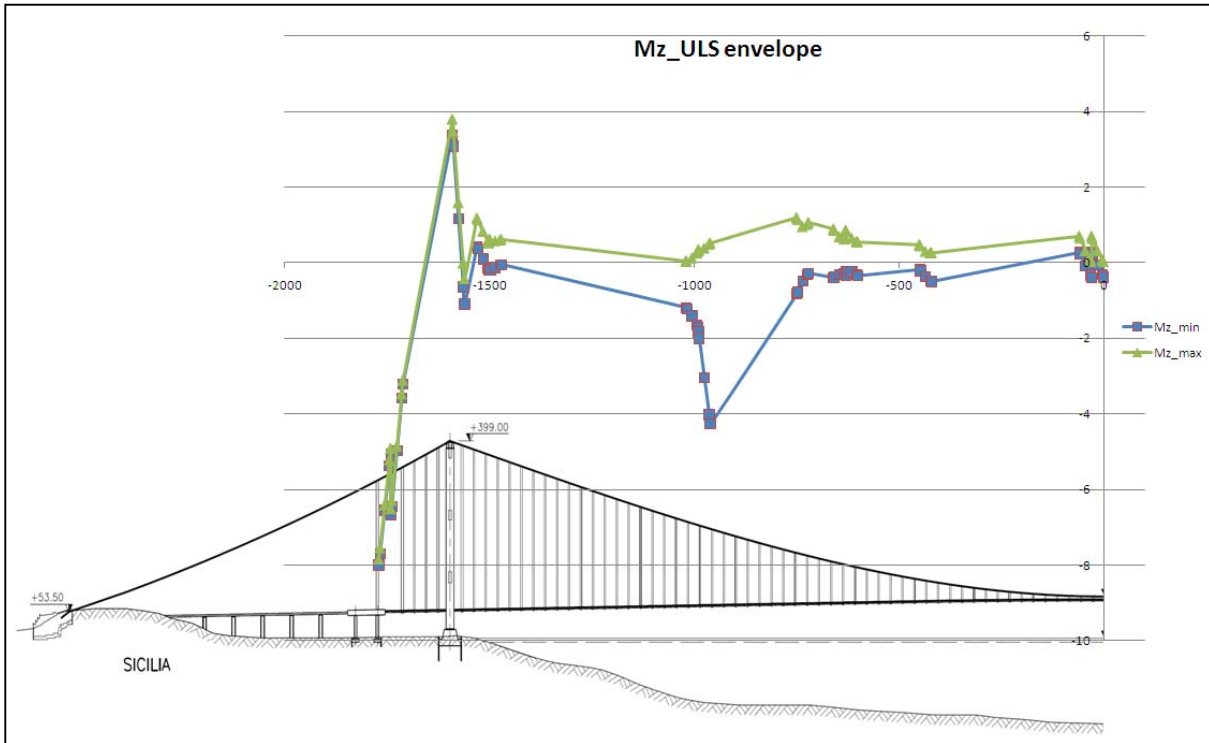
Figure 3-20 Sectional forces in road girder for rupture of hanger 30, Moment (MNm)
