# PONTE SULLO STRETTO DI MESSINA

## PROGETTO DEFINITIVO

The report contains the results of the special design investigations of hanger replacement and hanger rupture considered at the ultimate limit state. All results presented in the report are based on the global IBDAS beam-model version 3.3.

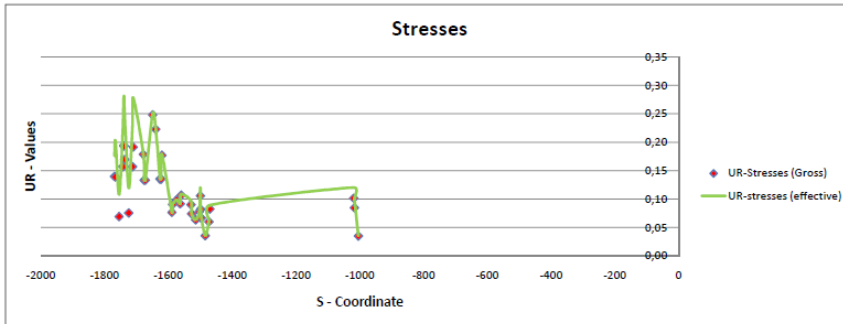
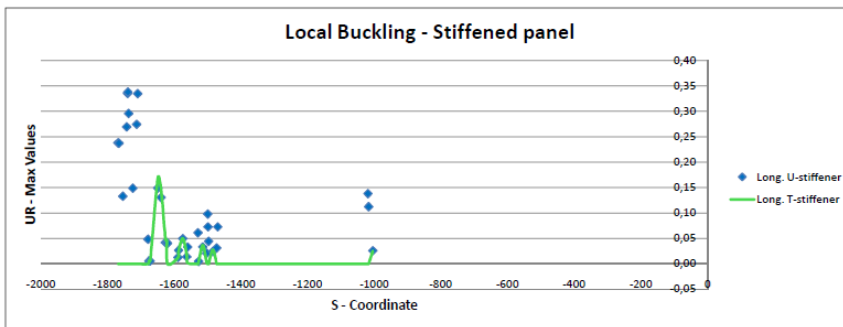
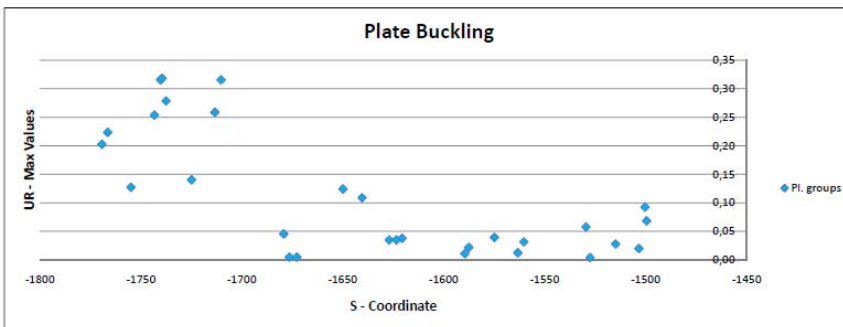
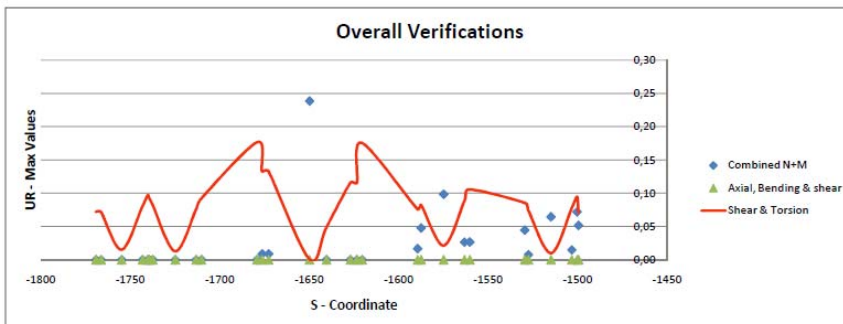
Figure 3-21 ADVERS results for rupture of Hanger 30, roadway girder

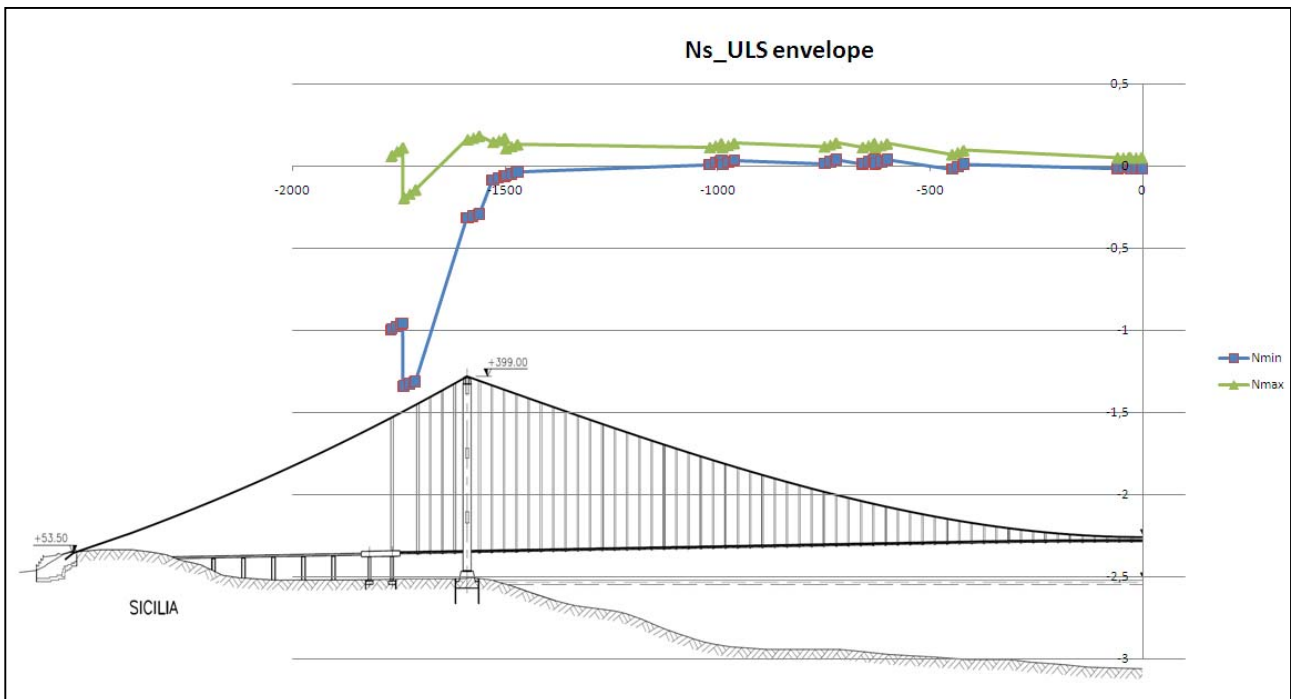
Figure 3-22 Sectional forces in rail girder for rupture of hanger 3, Normal force (MN)

Sectional force curves are given in the following illustrating the calculated sectional forces from the global IBDAS model in few discrete point. These curves illustrate the behaviour and effect in the girder due to rupture of selected hangers. All results are ULS envelopes and show the max sectional forces in 3-4 points within a girder section.

From the various section force curves it is evident that rupture of a hanger has a large effect on the adjacent spans, indicated by a peak in forces at the location of rupture mainly due to the dynamic effects. It can also be seen that the effect fades out rapidly through the bridge.

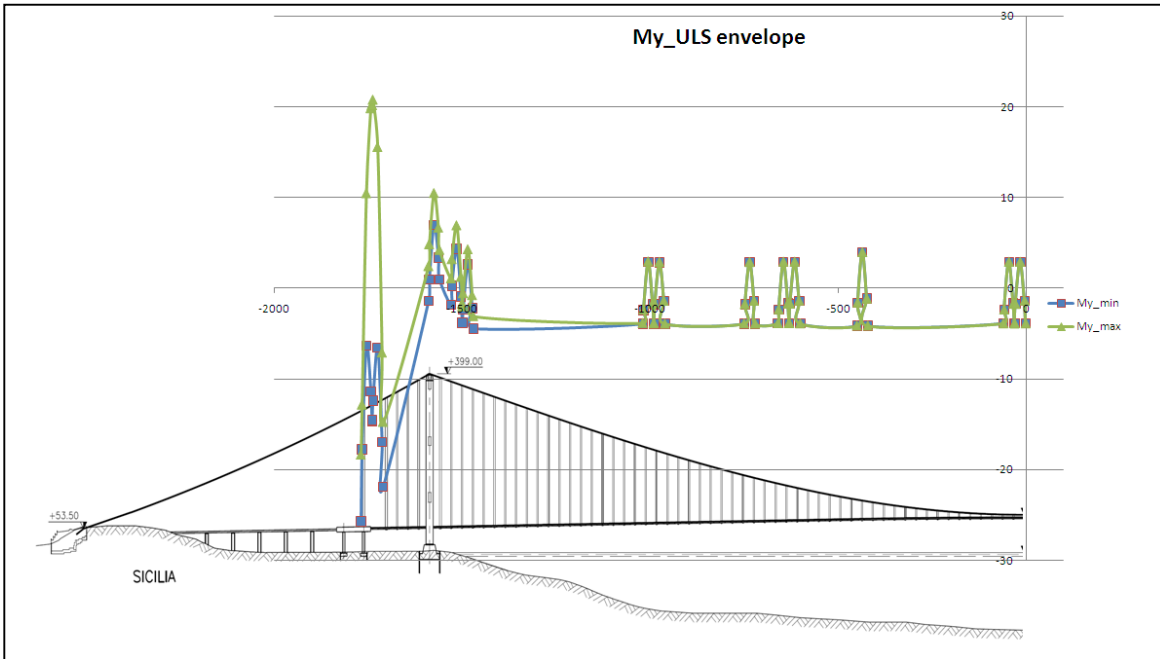
Figure 3-23 Sectional forces in rail girder for rupture of hanger 3, Moment (MNm)

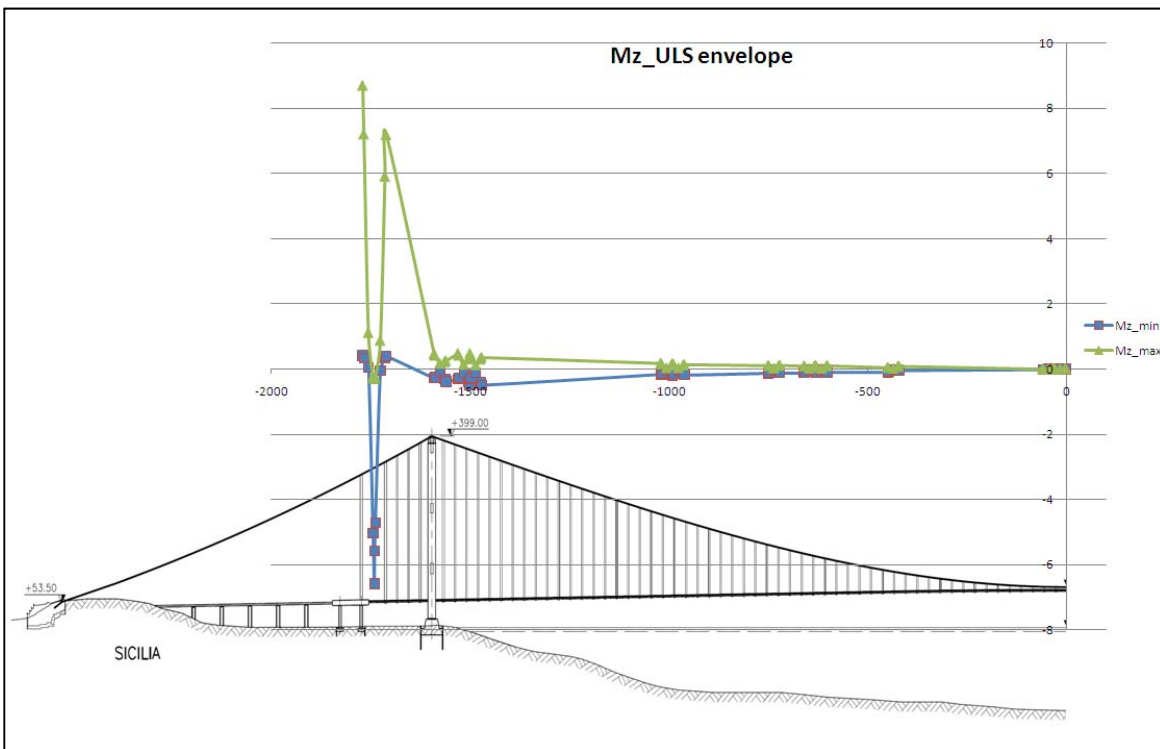
Figure 3-24 Sectional forces in rail girder for rupture of hanger 3, Moment (MNm)

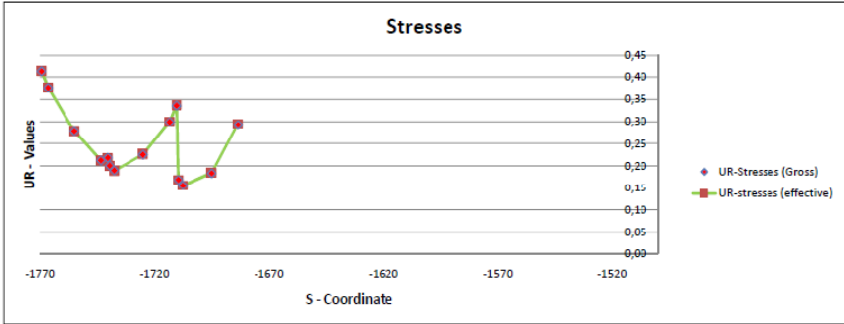
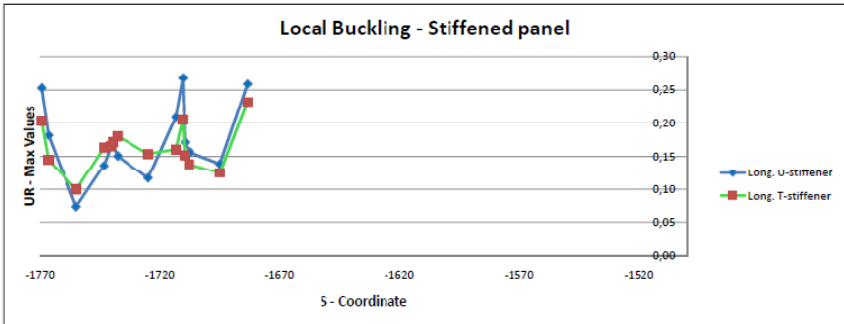
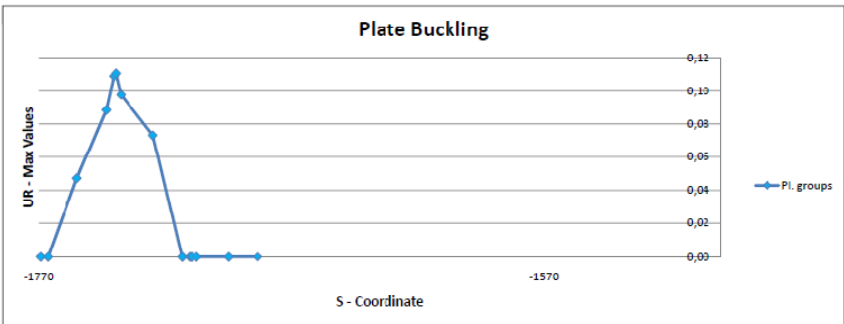
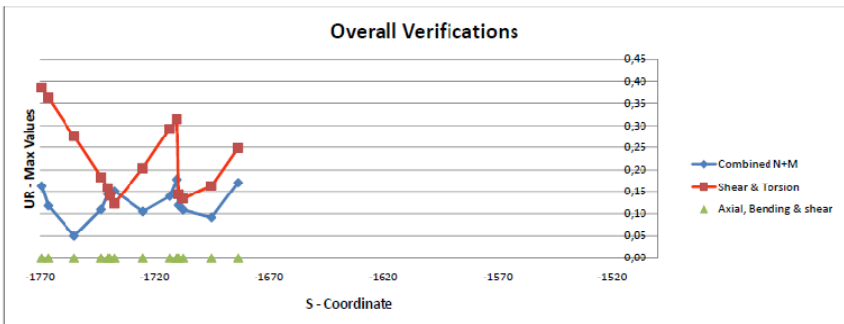
Figure 3-25 ADVERS results for rupture of Hanger 3, railway girder CF3/5/6

The calculations of the effect of hanger rupture on the railway girder are parted in girder types due to the calculation method used in ADVERS. From the results in the following figures it can be seen that the railway girder has sufficient capacity in case of rupture of the considered hangers.

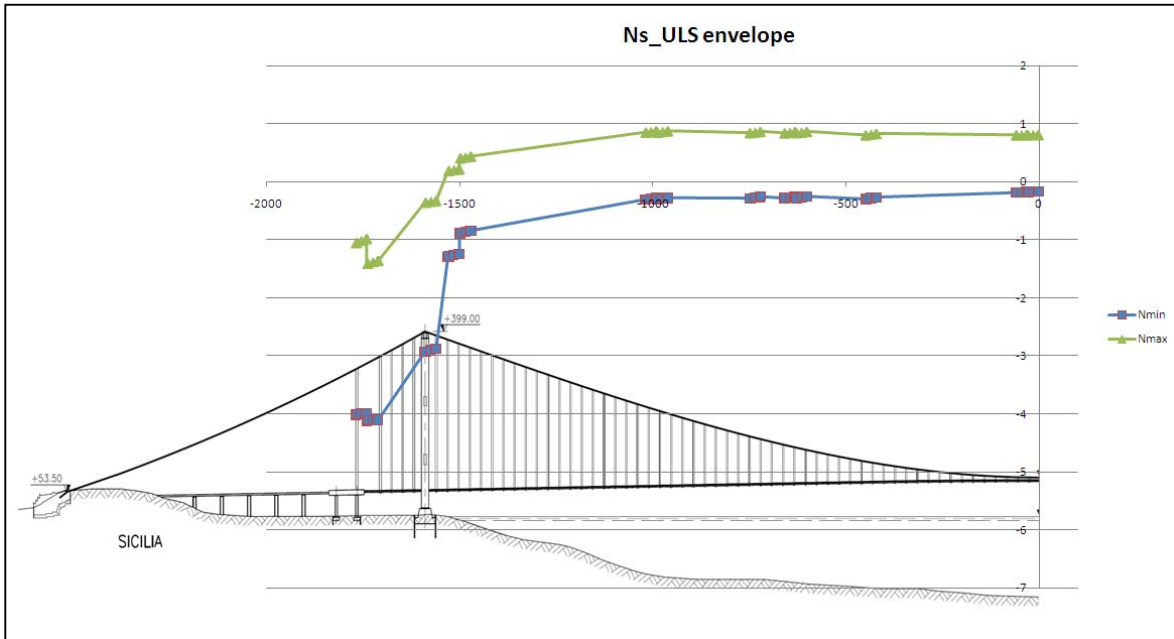
Figure 3-26 Sectional forces in rail girder for rupture of hanger 5, Normal force (MN)

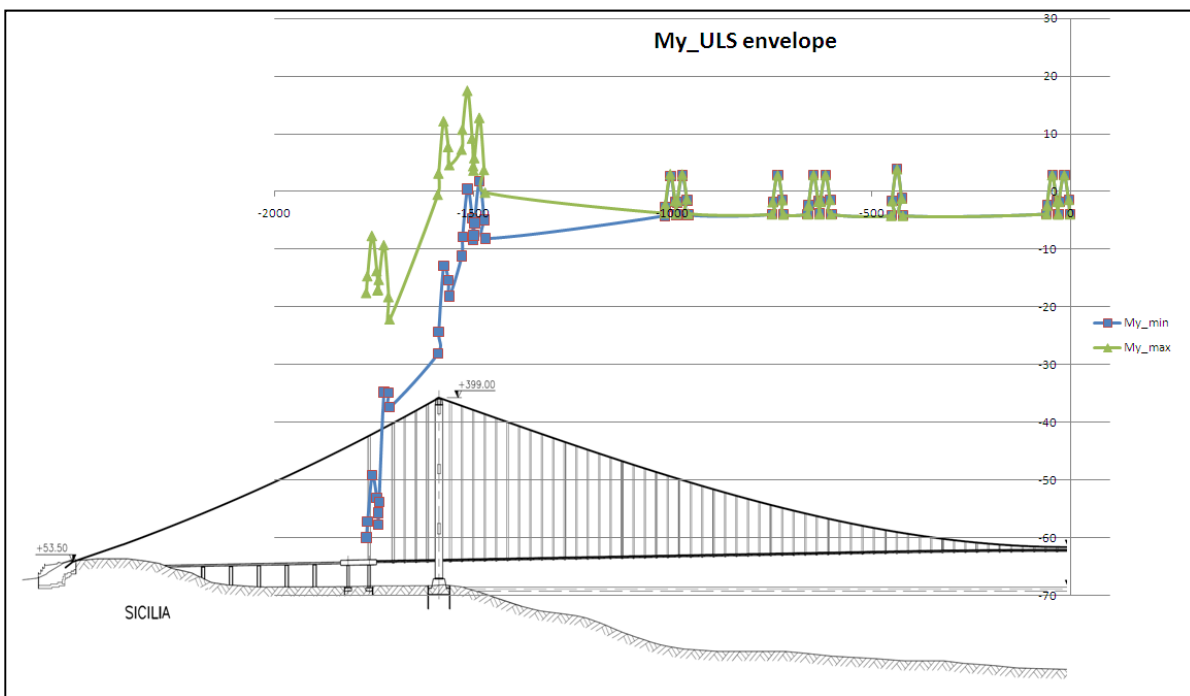
Figure 3-27 Sectional forces in rail girder for rupture of hanger 5, Moment (MNm)

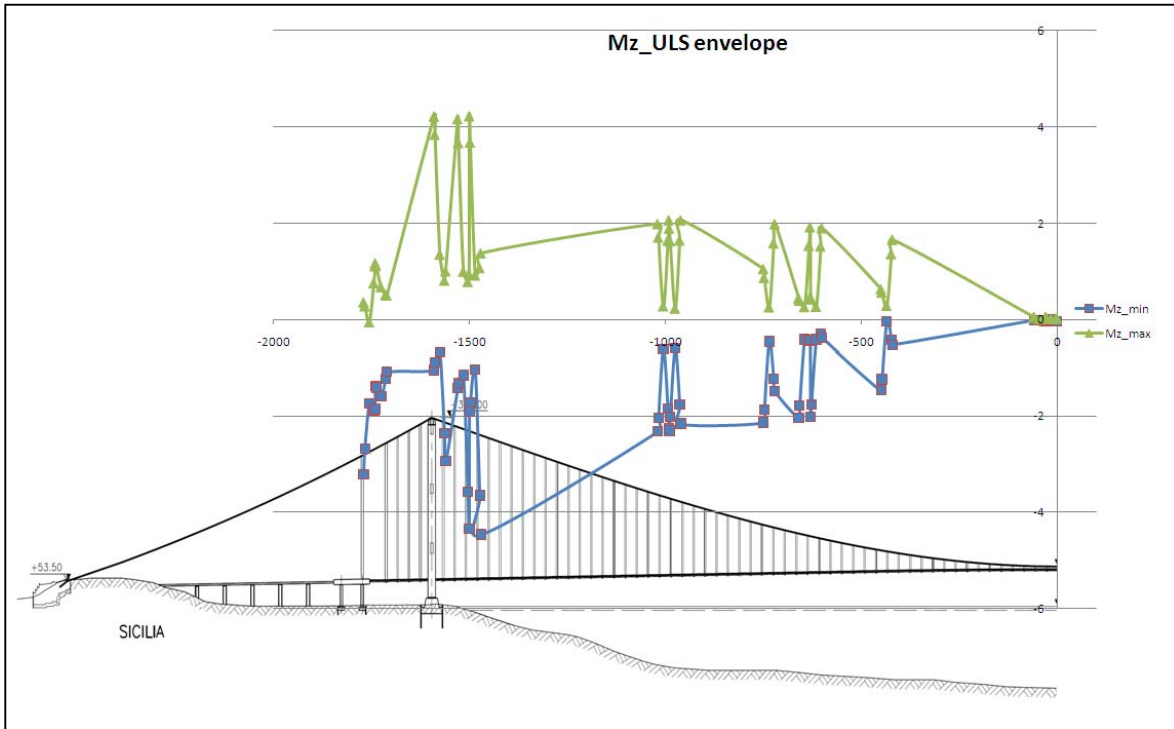
Figure 3-28 Sectional forces in rail girder for rupture of hanger 5, Moment (MNm)

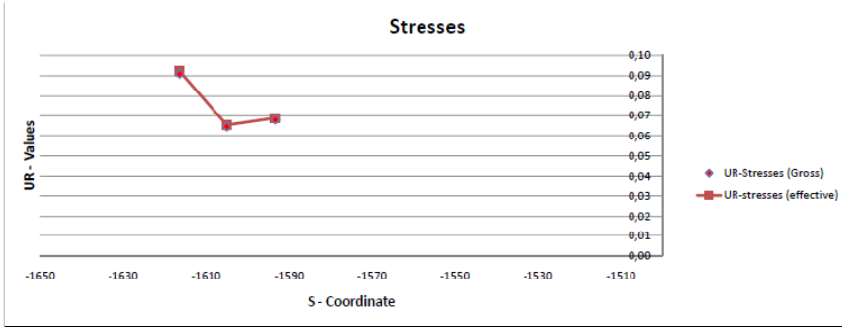
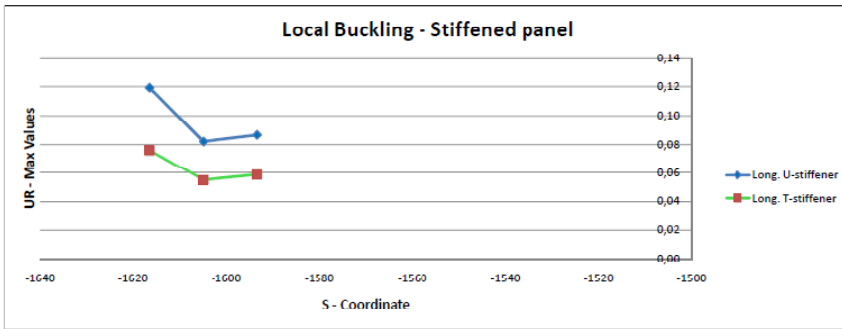
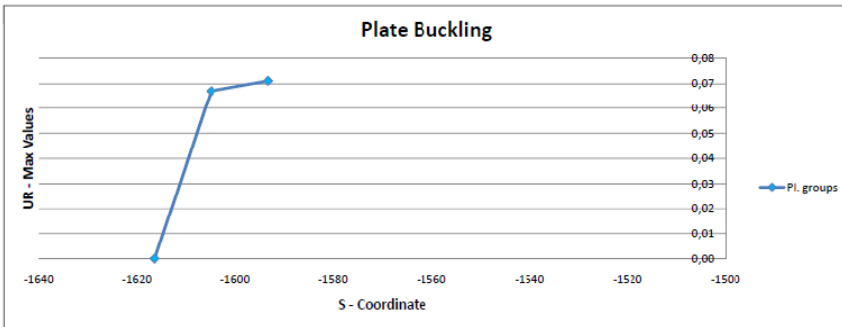
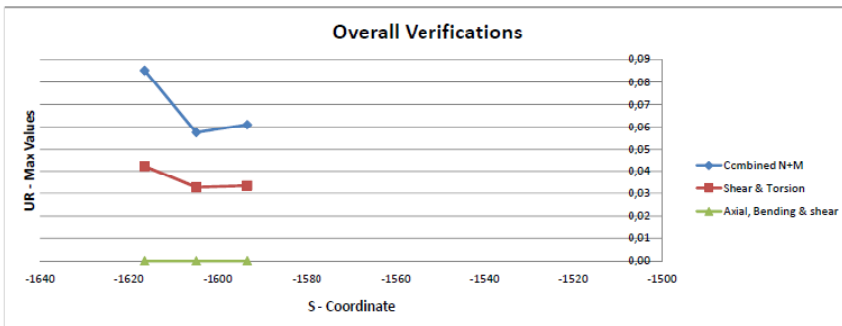
Figure 3-30 ADVERS results for rupture of Hanger 5, railway girder CF4

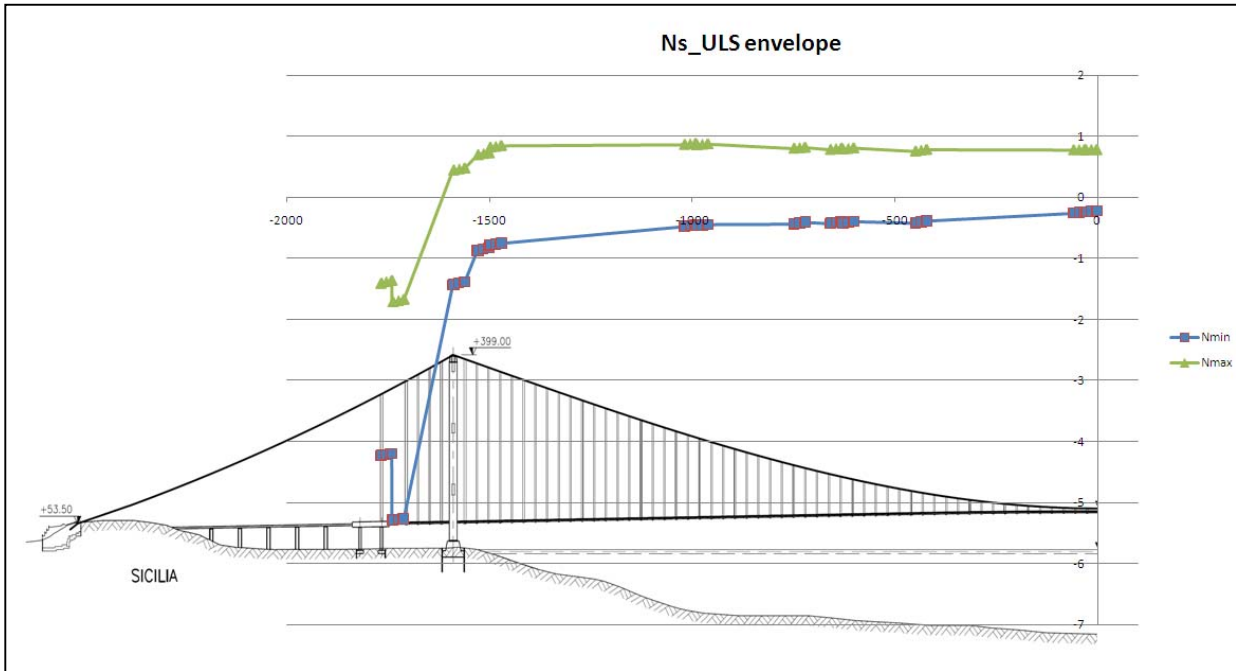
Figure 3-31 Sectional forces in rail girder for rupture of hanger 6, Normal force (MN)

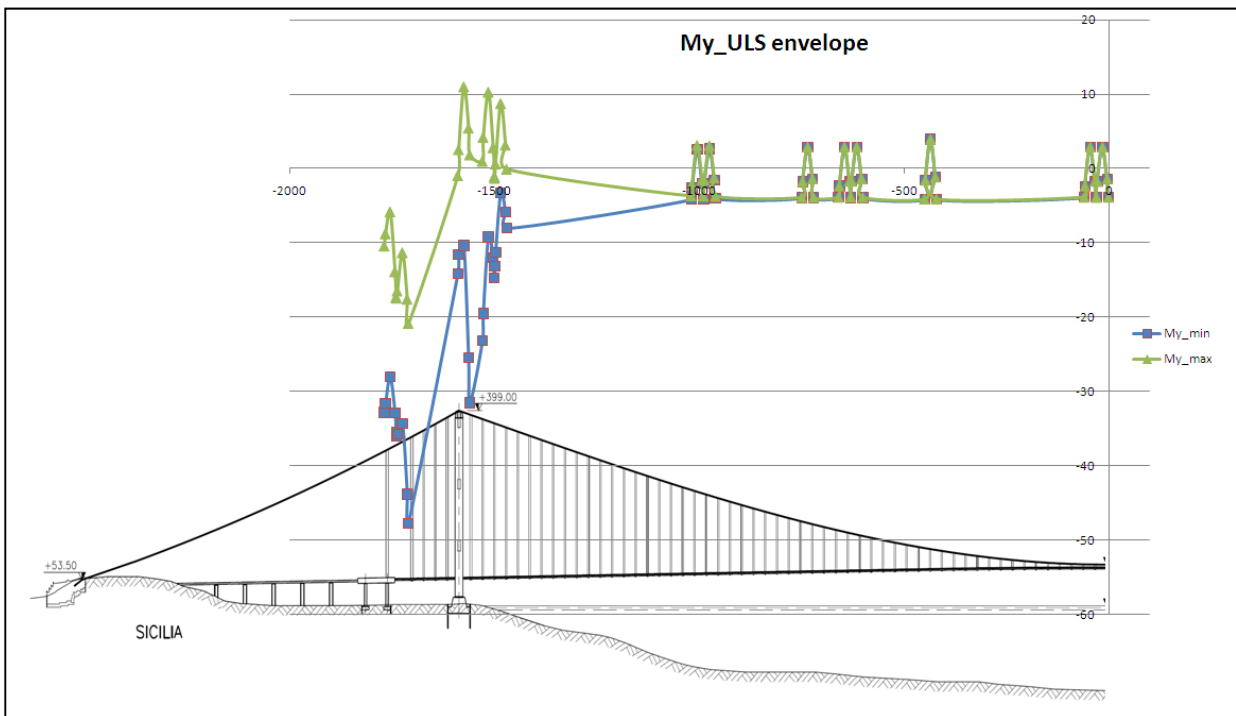
Figure 3-32 Sectional forces in rail girder for rupture of hanger 6, Moment (MNm)

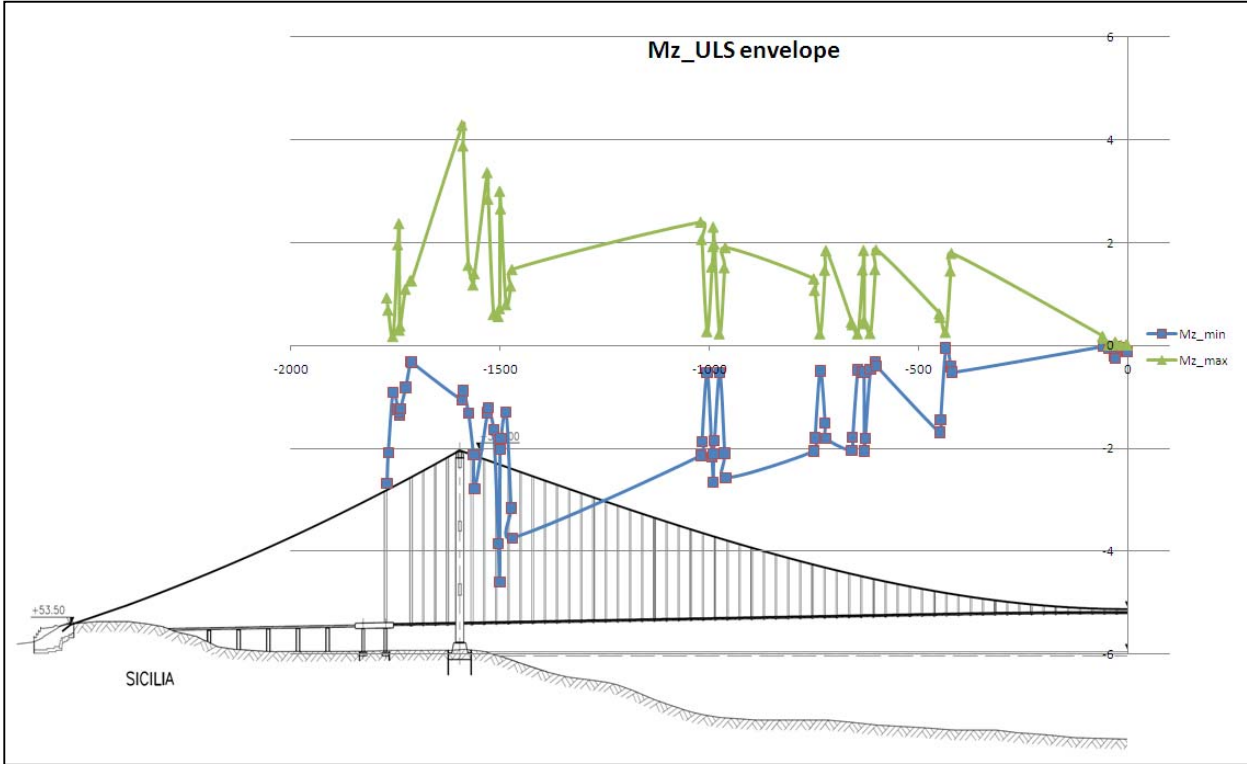
Figure 3-33 Sectional forces in rail girder for rupture of hanger 6, Moment (MNm)

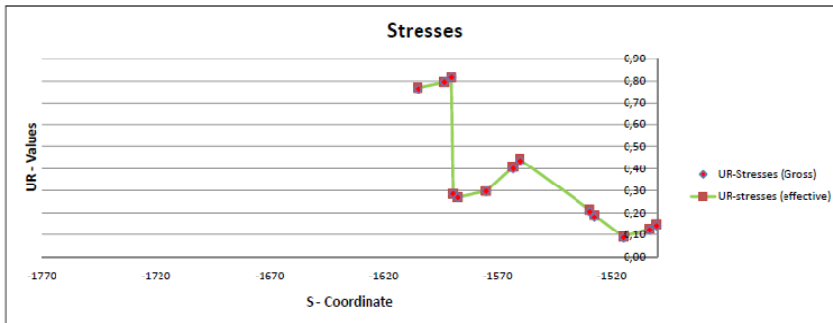
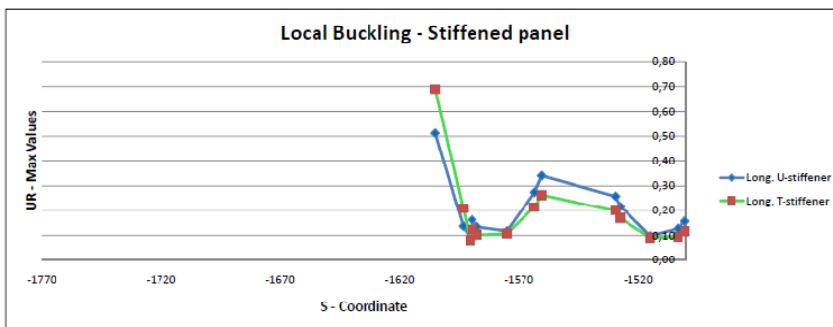
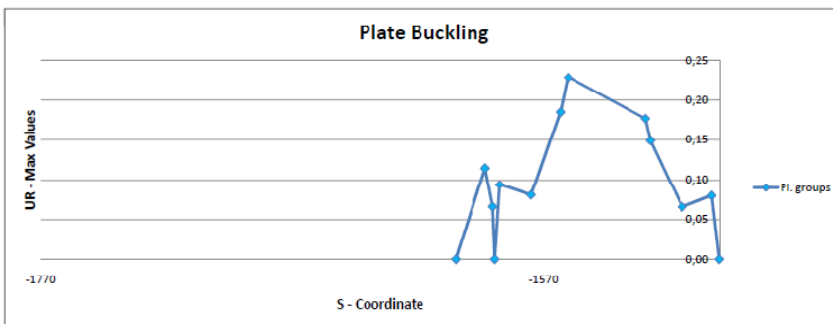
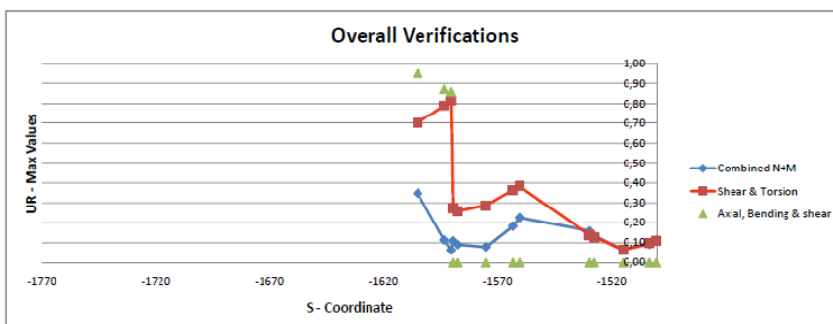
Figure 3-34 ADVERS results for rupture of Hanger 6, railway girder CF3/5/6

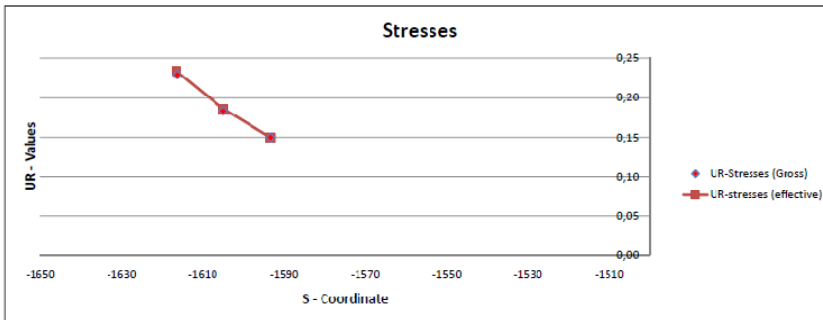
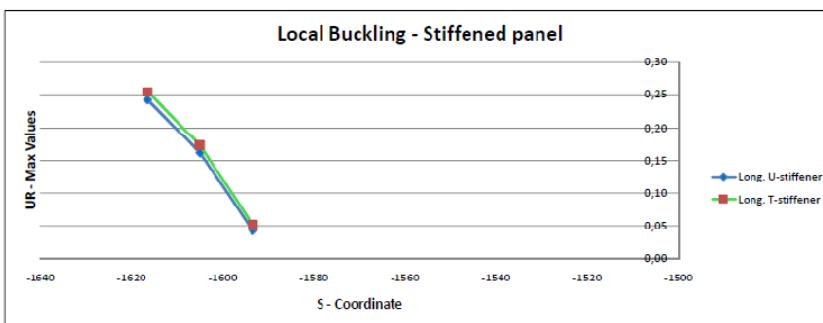
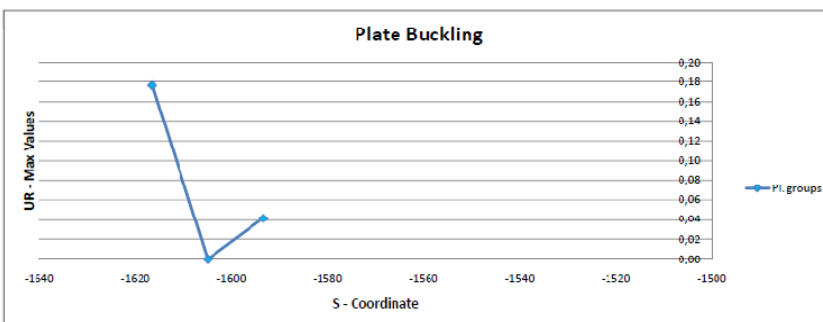
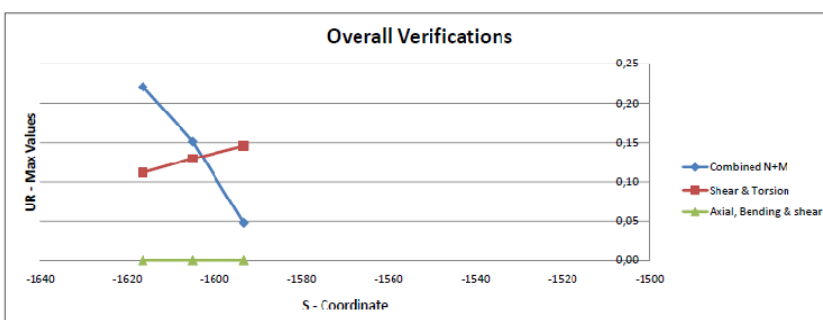
Figure 3-35 ADVERS results for rupture of Hanger 6, railway girder CF4

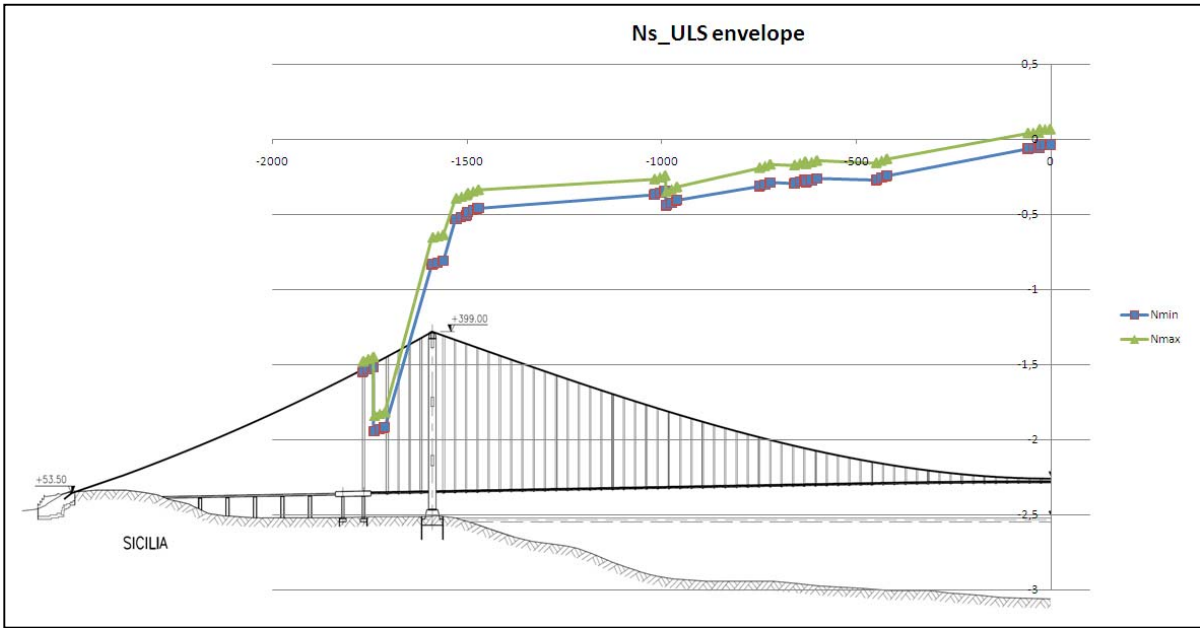
Figure 3-36 Sectional forces in rail girder for rupture of hanger 30, Normal force (MN)

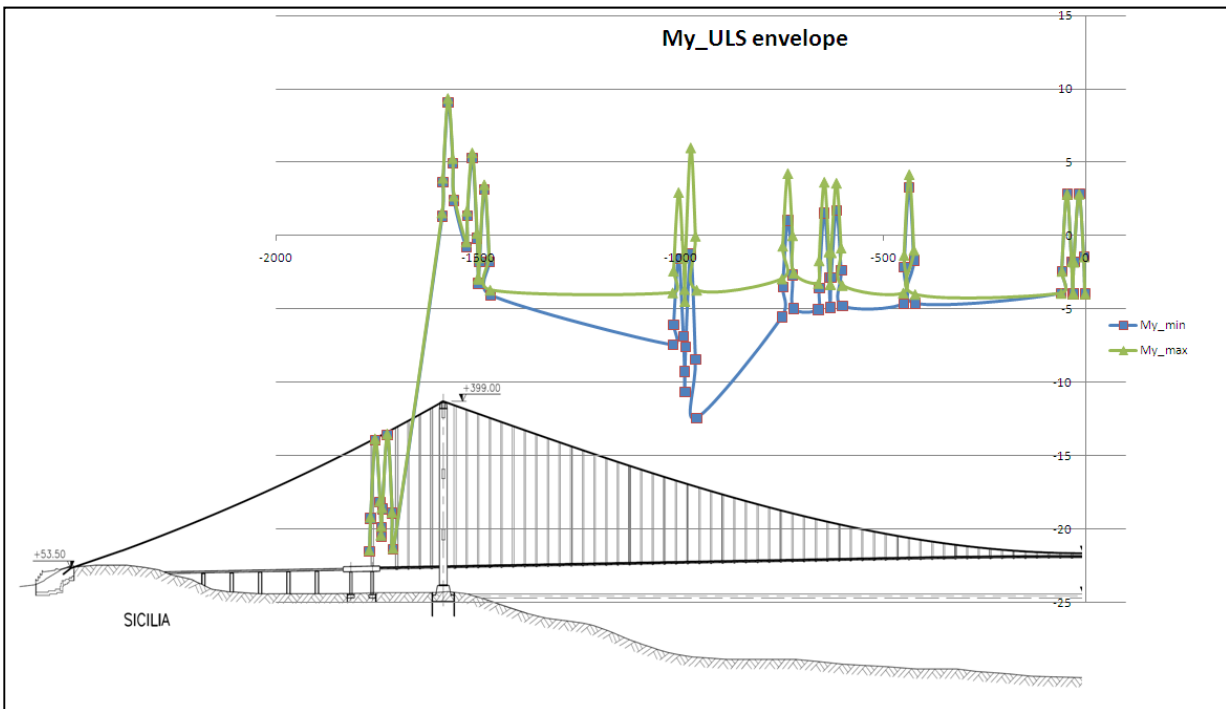
Figure 3-37 Sectional forces in rail girder for rupture of hanger 30, Moment (MNm)

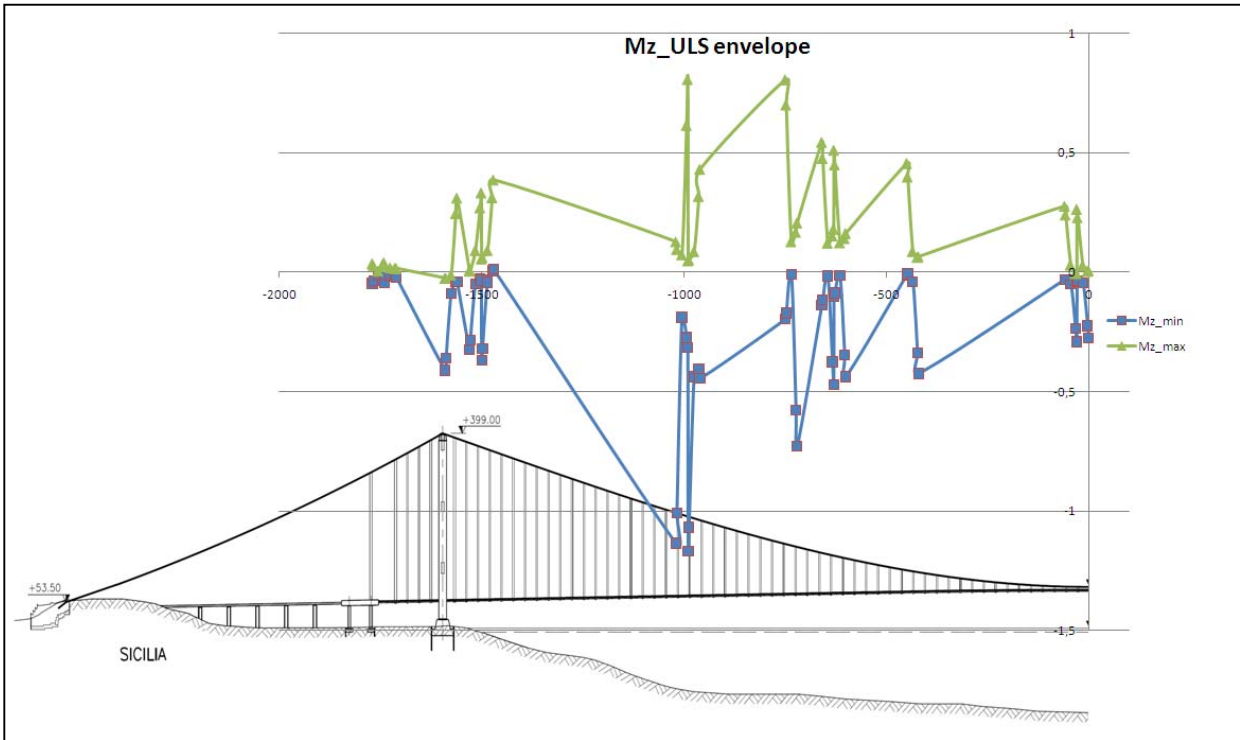
Figure 3-38 Sectional forces in rail girder for rupture of hanger 30, Moment (MNm)

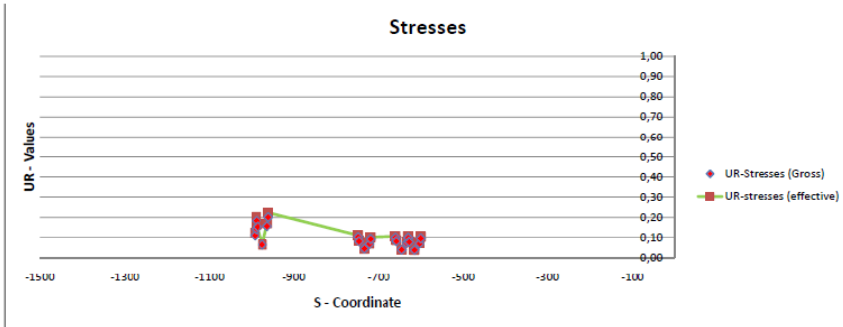
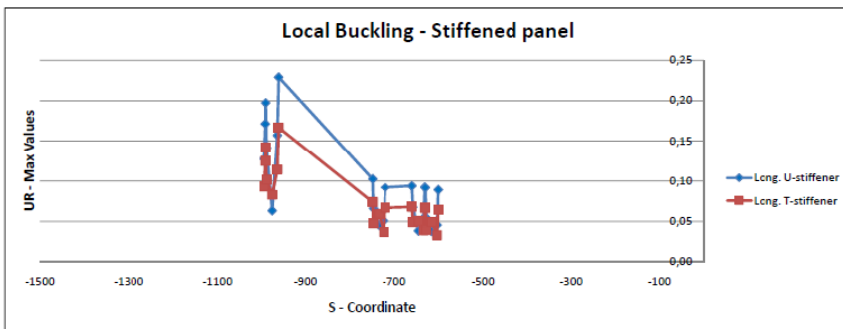
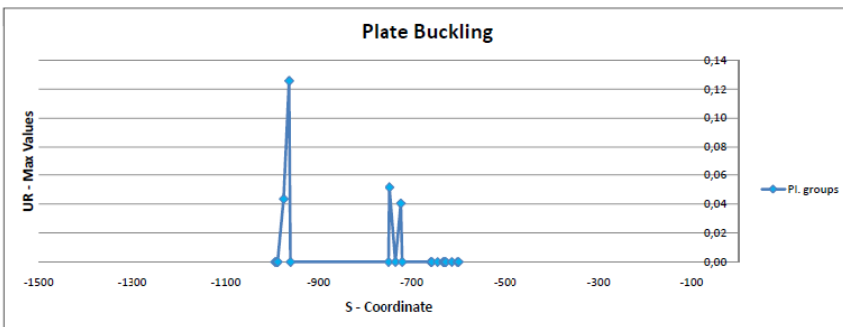
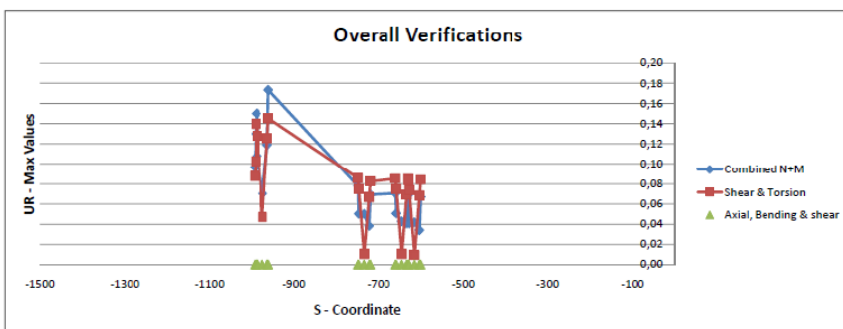
Figure 3-39 ADVERS results for rupture of Hanger 30, railway girder CF1

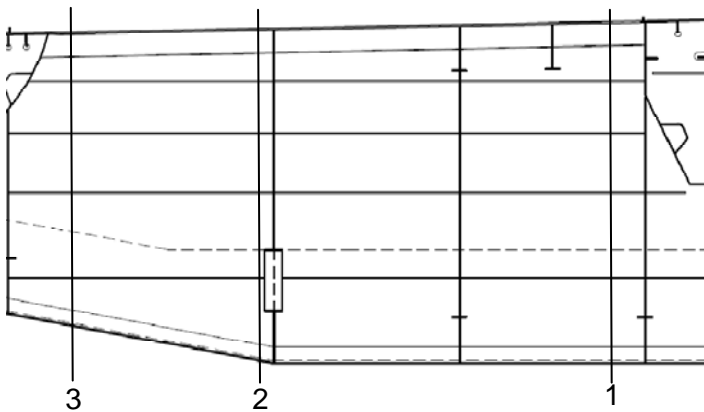
The calculations of the effect of hanger rupture on the cross girders can be seen in the following figures. For the cross girders three different sections in each cross girder is considered for the verification in ADVERS named section 1 to 3 from the railway towards the road girder, see Figure 3-40.

Figure 3-40 Location of investigated sections in the cross girder

In general it can be seen that the most critical section in the cross girder is at section 2. It can be seen that the cross girders has sufficient capacity in case of rupture of the considered hangers having  $UR < 1.0$ .

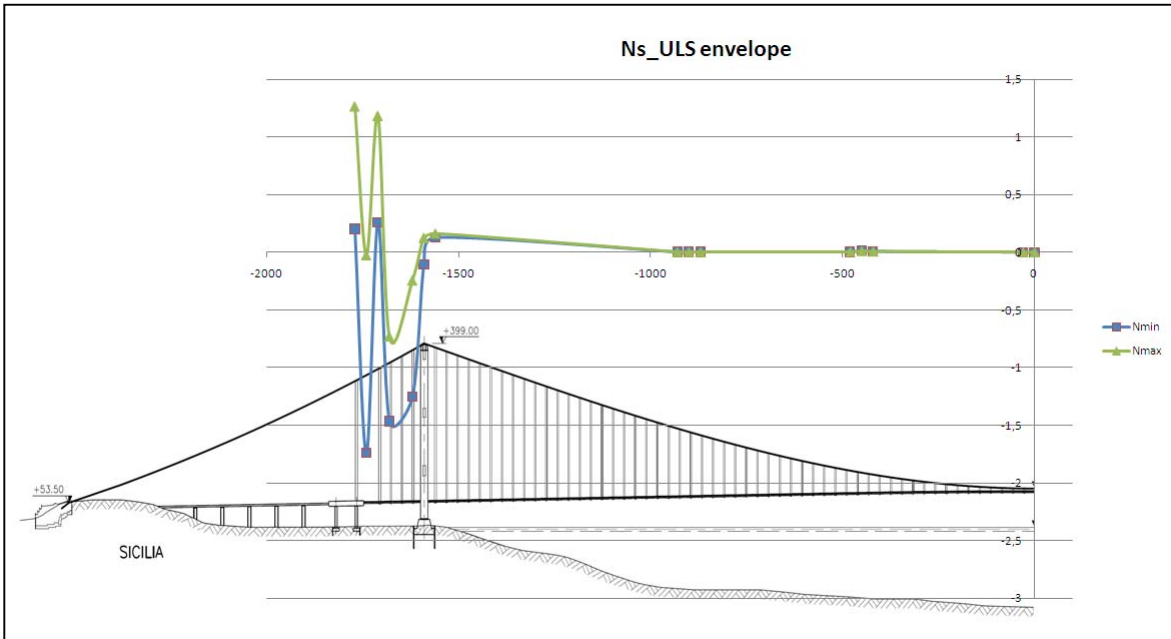
Figure 3-41 Sectional forces in cross girder for rupture of hanger 3, Normal force (MN)

Sectional force curves are given in the following illustrating the calculated sectional forces from the global IBDAS model in few discrete points. These curves illustrate the behaviour and effect in the girder due to rupture of selected hangers. All results are ULS envelopes and show the max sectional forces in the cross girder. For the sectional forces only values from section 1 is given.

From the various section force curves it is evident that rupture of a hanger has a large effect on the adjacent cross girders, indicated by a peak in forces at the location of rupture mainly due to the dynamic effects. It can also be seen that the effect fades out rapidly through the bridge.

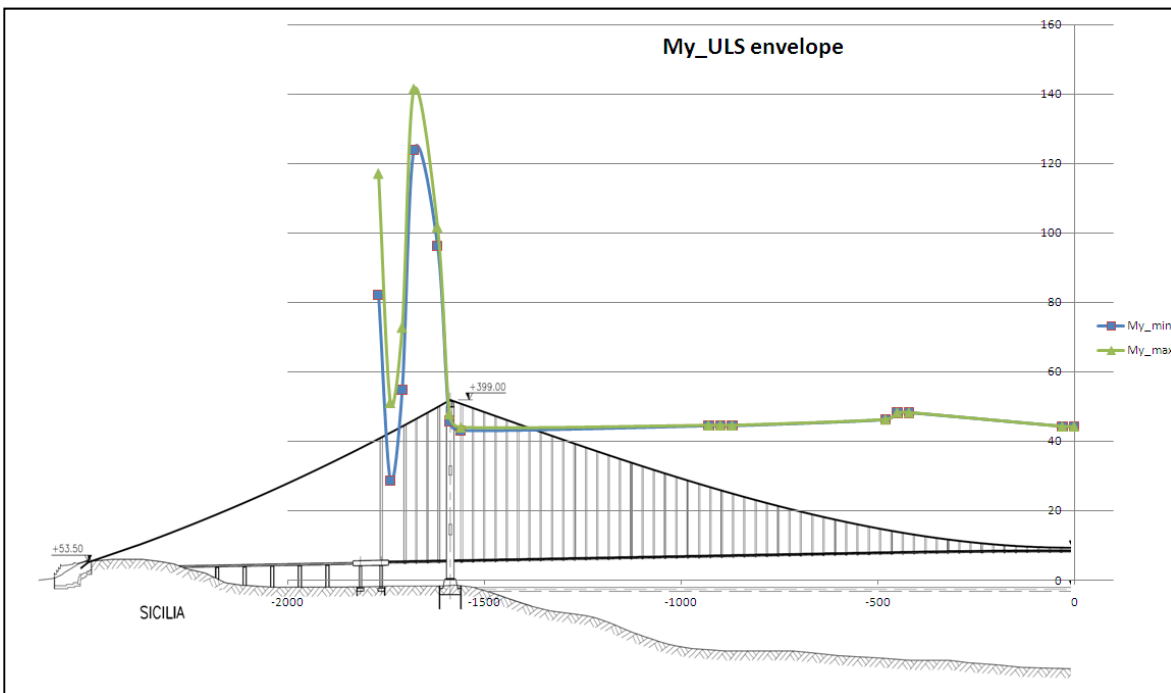
Figure 3-42 Sectional forces in cross girder for rupture of hanger 3, Moment (MNm)

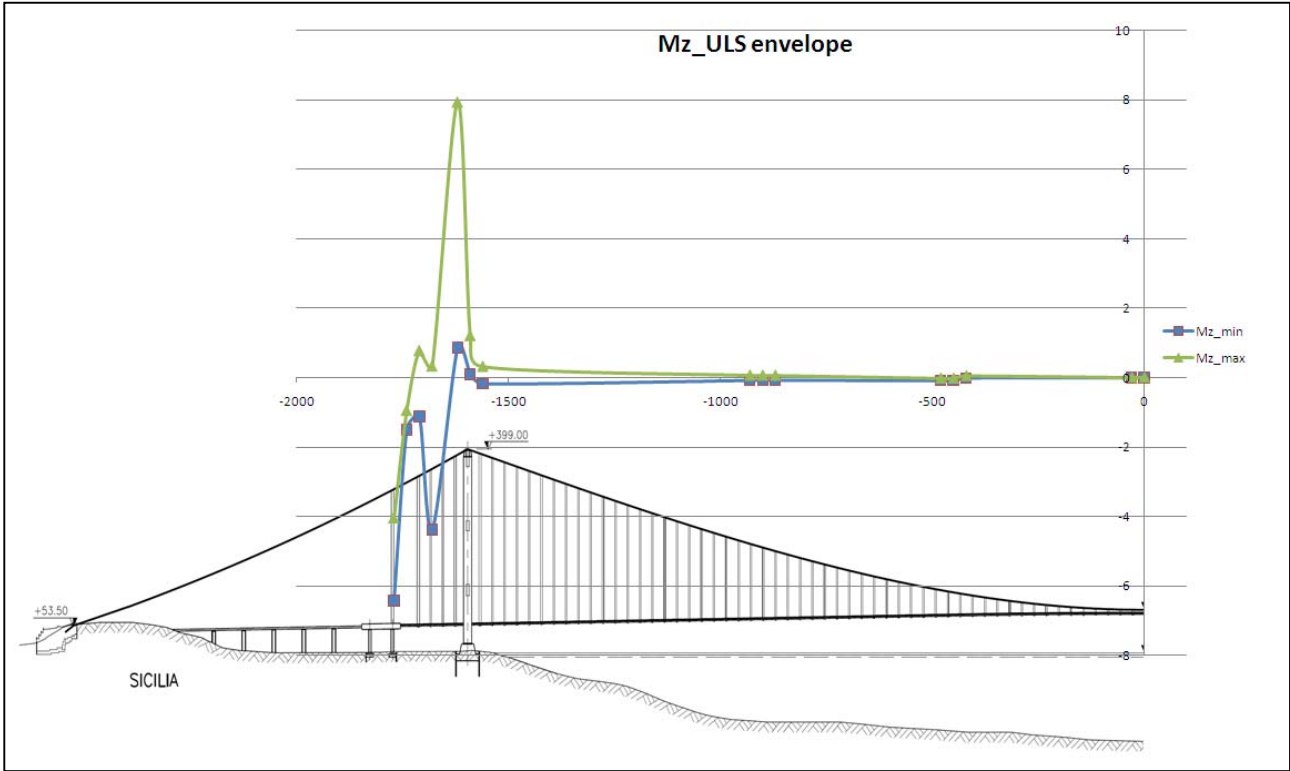
Figure 3-43 Sectional forces in cross girder for rupture of hanger 3, Moment (MNm)

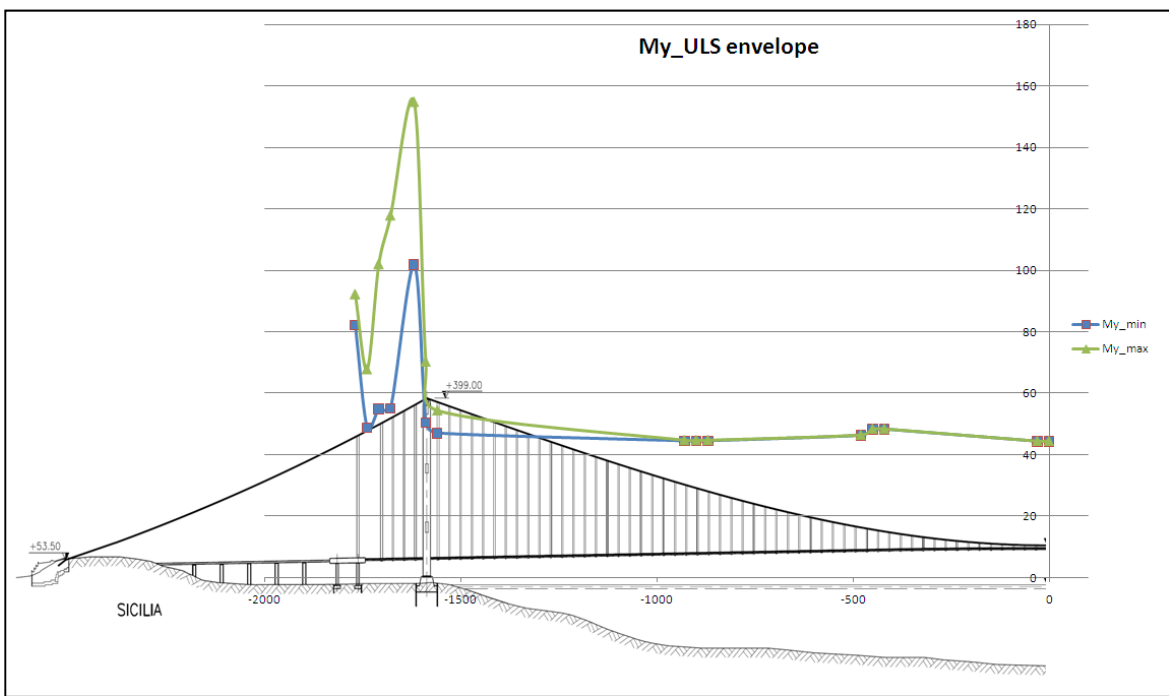
Figure 3-49 Sectional forces in cross girder for rupture of hanger 5, Moment (MNm)

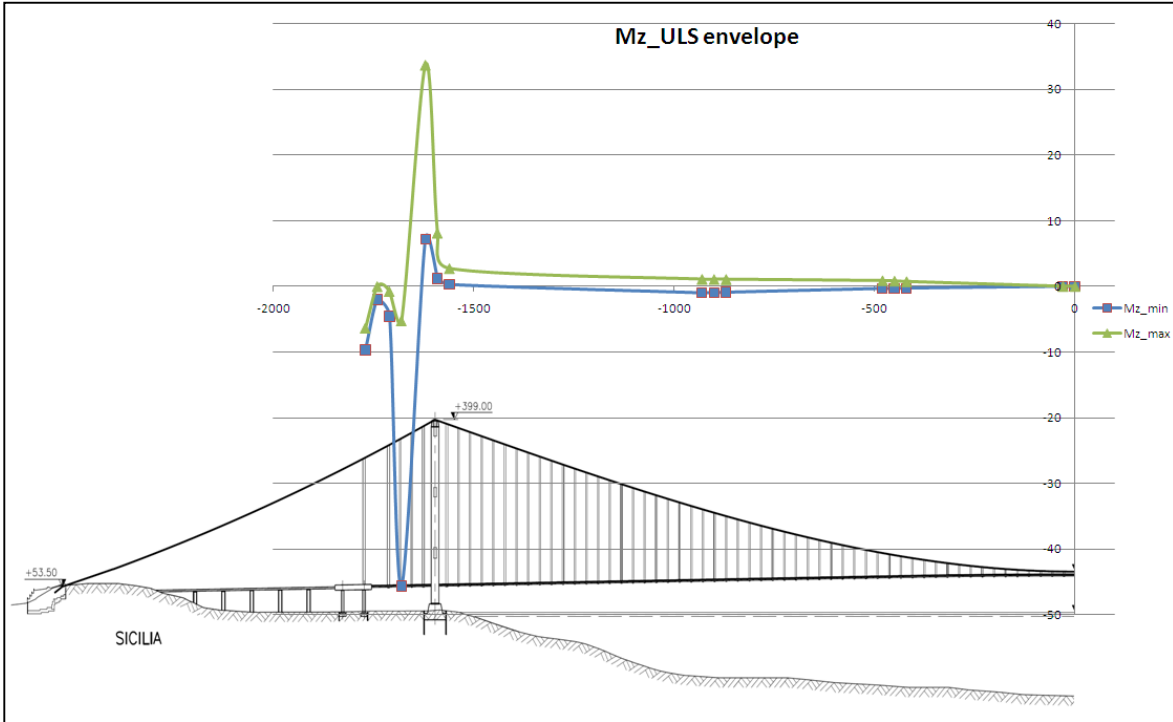
Figure 3-50 Sectional forces in cross girder for rupture of hanger 5, Moment (MNm)

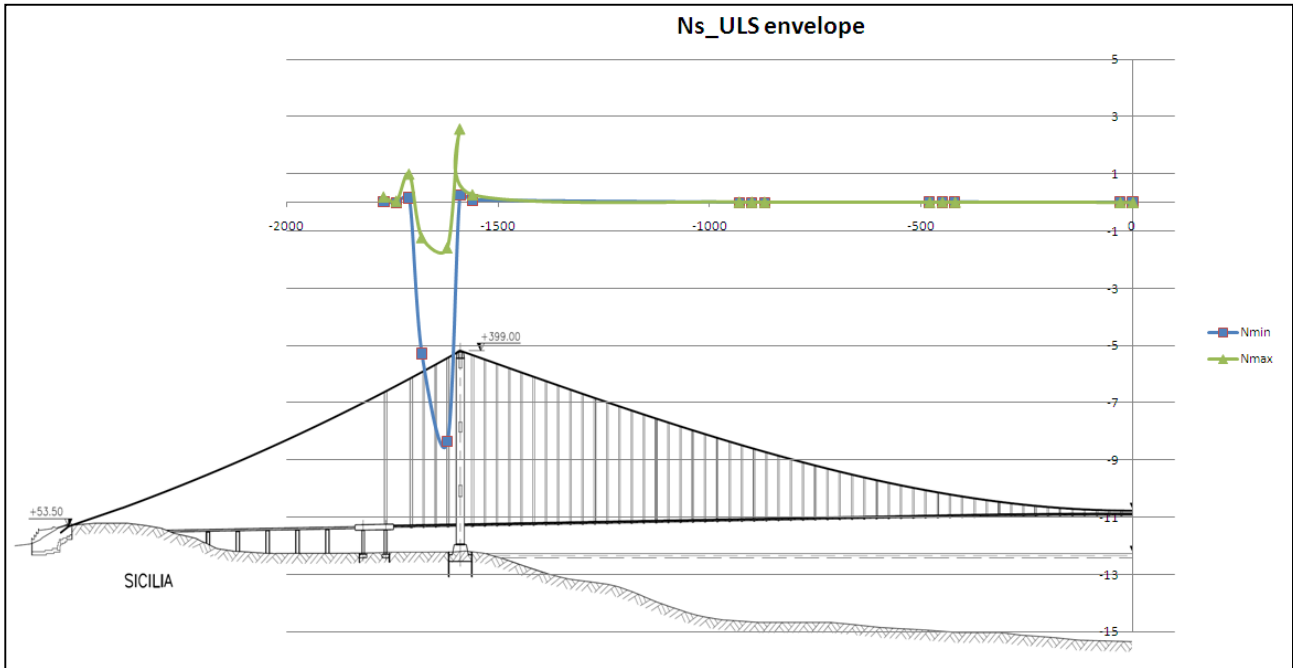
Figure 3-57 Sectional forces in cross girder for rupture of hanger 6, Normal force (MN)
