# PONTE SULLO STRETTO DI MESSINA

## PROGETTO DEFINITIVO

The report contains the results of the special design investigations of hanger replacement and hanger rupture considered at the ultimate limit state. All results presented in the report are based on the global IBDAS beam-model version 3.3.

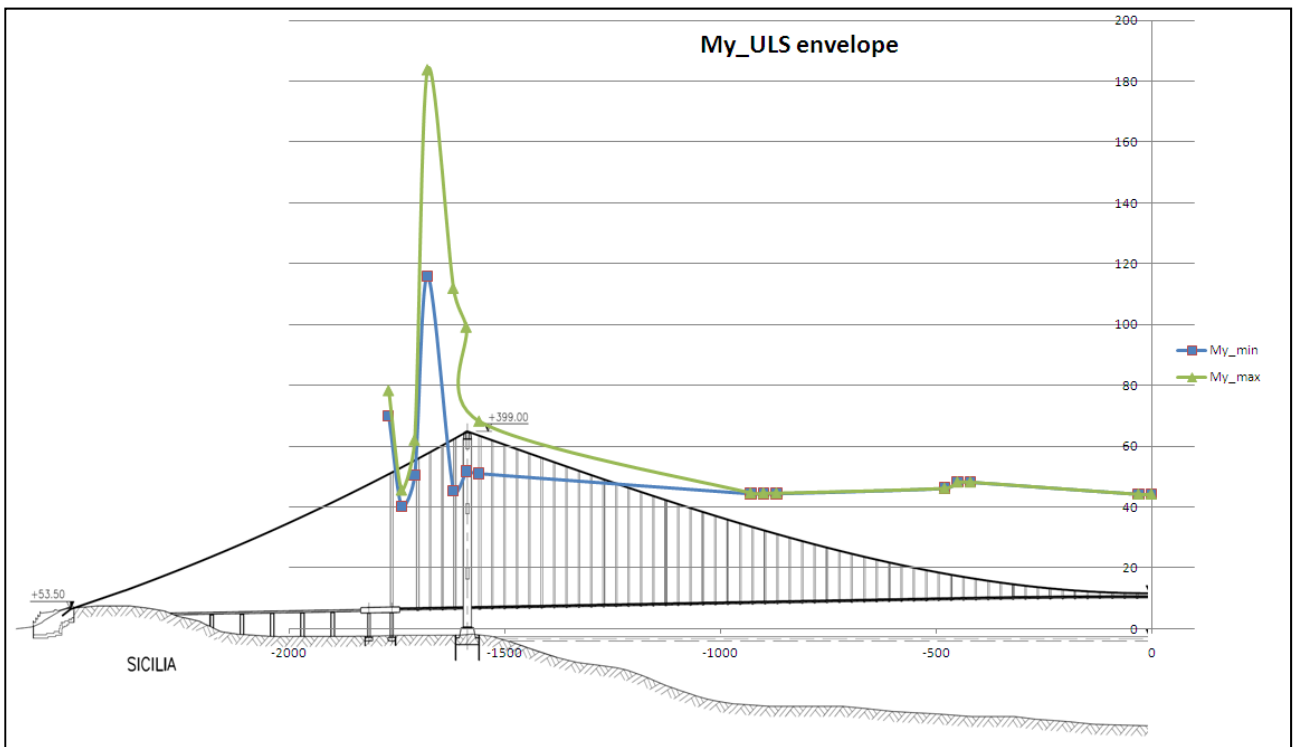
Figure 3-58 Sectional forces in cross girder for rupture of hanger 6, Moment (MNm)

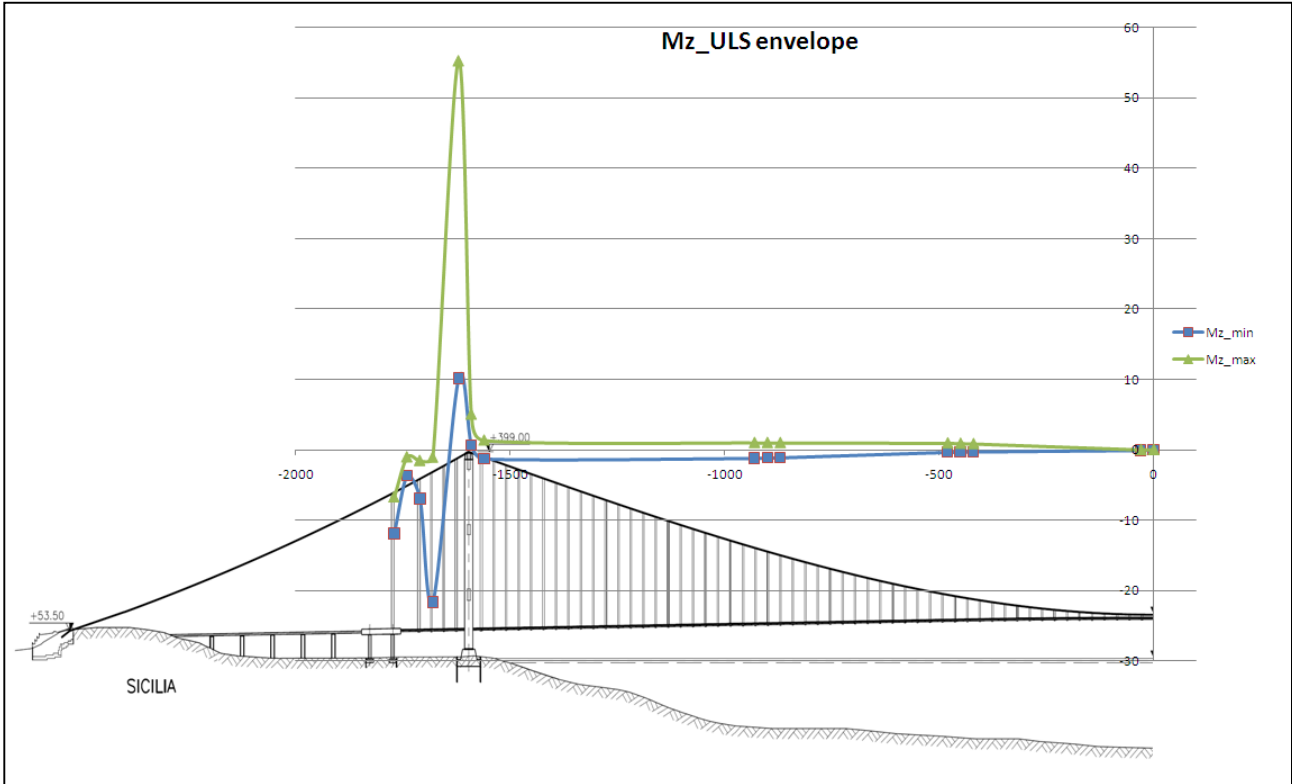
Figure 3-59 Sectional forces in cross girder for rupture of hanger 6, Moment (MNm)
