Relazione Finale sulla Verifica di Ottemperanza in Corso d'Opera alla
Prescrizione A.42

**OPL00-C493-601-Y-TPF-0002- Monitoraggio dei Mammiferi Marini. Nota Tecnica:
Guasto del Sistema di monitoraggio "Sonoboa" e soluzioni alternative indivi-
duate**

Monitoraggio dei Mammiferi Marini

Nota Tecnica: Guasto del Sistema di monitoraggio "Sonoboa" e soluzioni alternative individuate

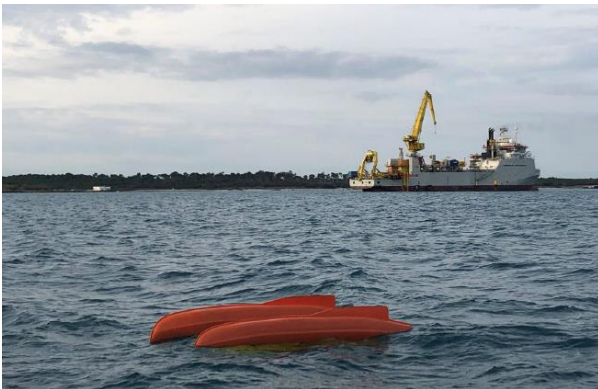
1. Sonoboa ribaltata

Le cause individuate all'origine dell'interruzione della trasmissione dei dati rilevati dall'idrofono installato sulla Sonoboa sono legate al ribaltamento del catamarano e alla permanenza in acqua di mare della strumentazione nonché alla perdita dell'antenna di trasmissione.

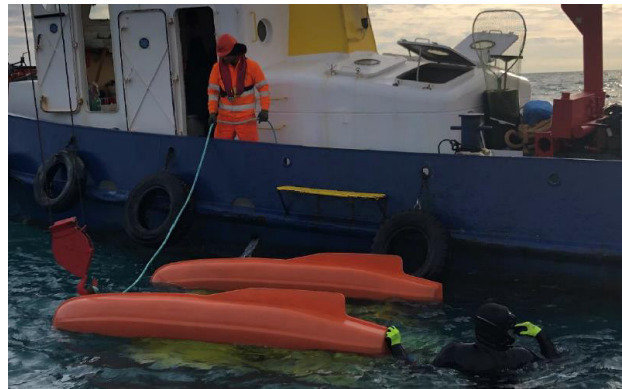
2. Fase iniziale di recupero

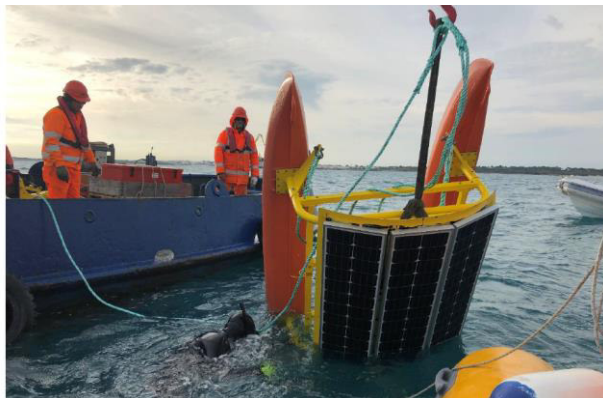
3. Fase di rotazione della Sonoboa

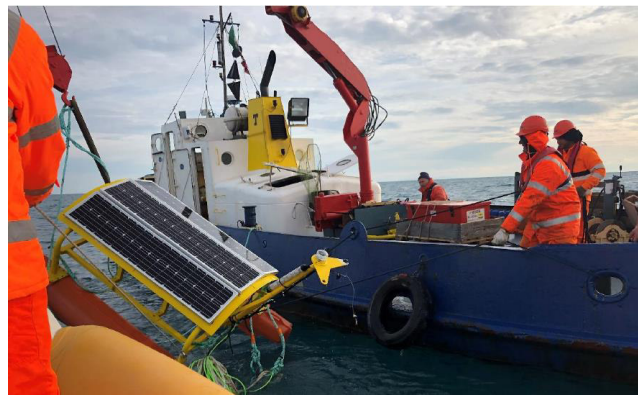
4. Fase di rotazione della Sonoboa

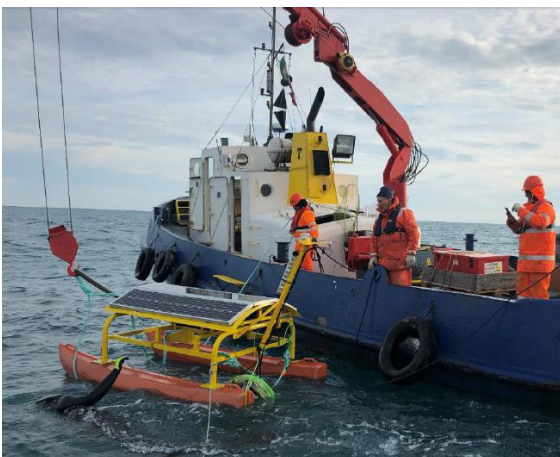
5. Riposizionamento della Sonoboa

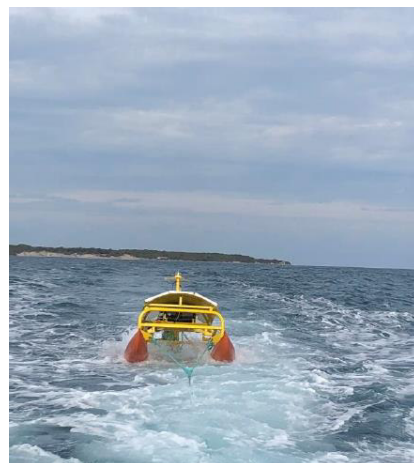
6. Traino
